PRESERVATION MASTER PLAN  
FOR  
**OLD MAIN**  
*University of Arizona*  
*Tucson*  
1891~2011

*Designed by James M. Creighton, Architect, 1887*  
*Constructed by M. J. Sullivan, Builder, 1887-1891*

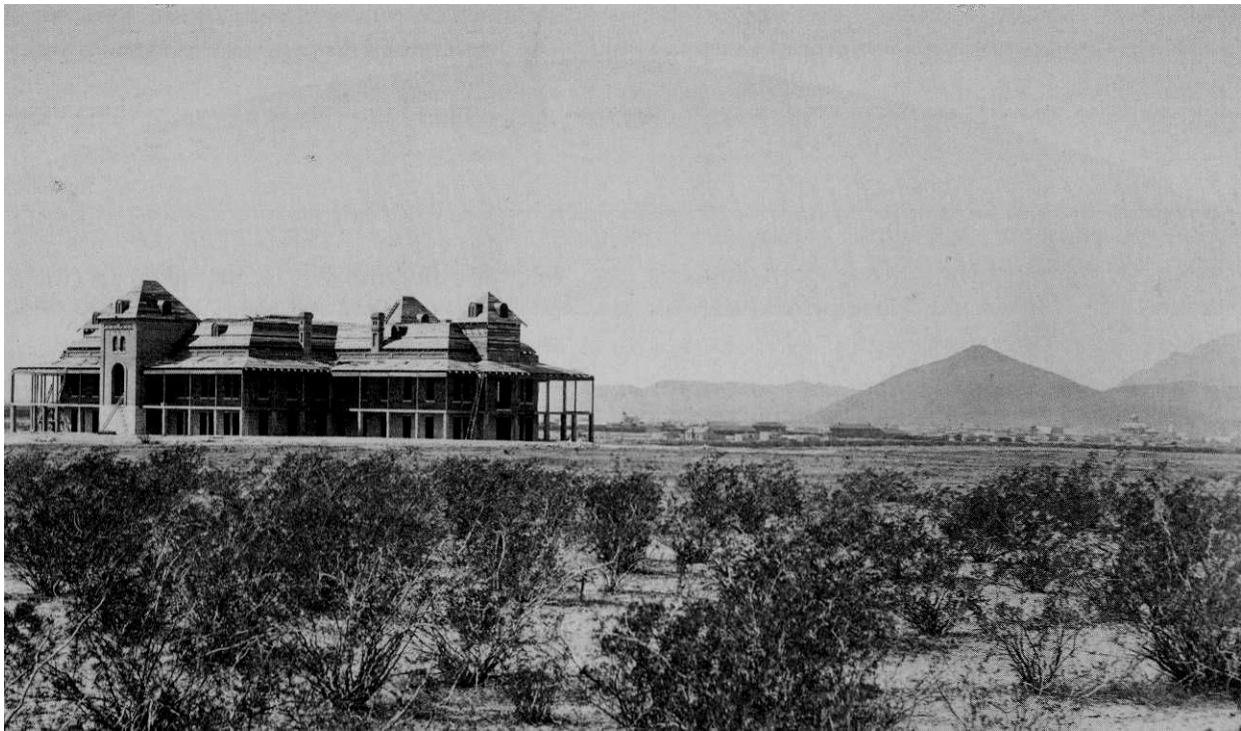
*Figure A - Old Main under construction, 1889; view looking southwest towards downtown Tucson and A-Mountain. The roof is framed and sheathed, but metal roofing has yet to be installed. Ground was broken October 27, 1887, and construction completed October 1, 1891 (Ball, p. 5)*

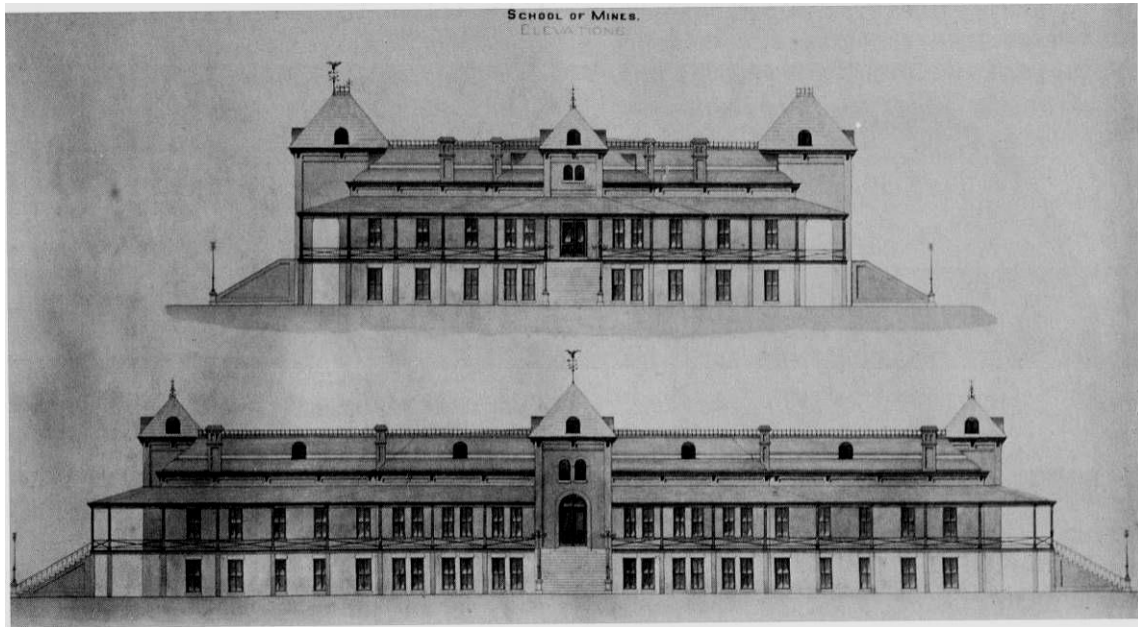
**Figure B** - Original elevations for the 'School of Mines' by James M. Creighton displays the wrap-around porch and sunken lower story of the French Colonial style – climatically suited to Arizona's intense sun & heat – combined with the towers, spires, crests and dormers of the rare Chateausque style, that briefly held sway in the late 1800s. Old Main shares features with the 18<sup>th</sup> C. plantation houses of Louisiana, blended with late 19<sup>th</sup> C. Victorian revival styles of the Territorial period of Arizona.

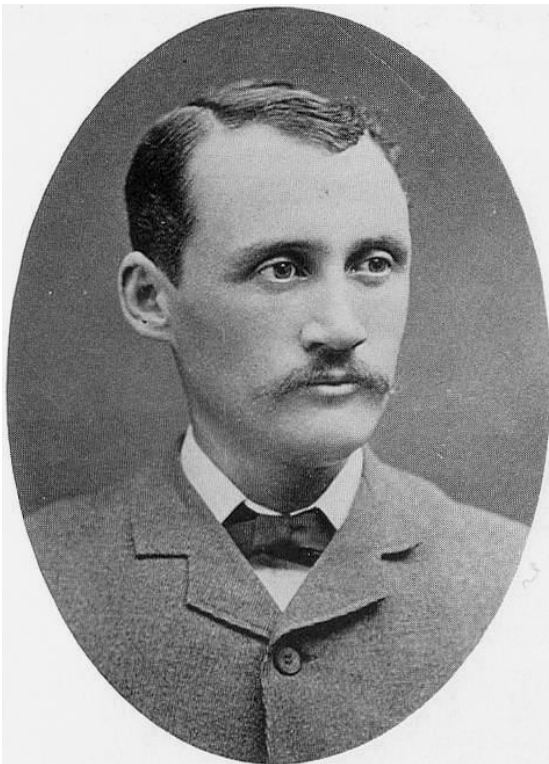
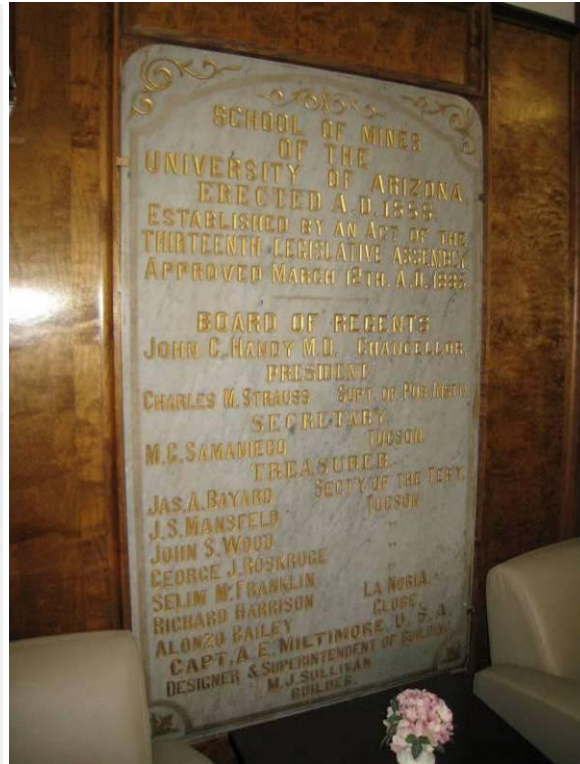
**Figure C** - The architect James Miller Creighton. According to the National Register nomination and the marble plaque at Old Main, the builder was M.J. Sullivan. Oddly the plaque makes no mention of Creighton; instead it credits "Capt. A. E. Miltimore, U.S.A." as "Designer & Superintendent of Building", in what may be one of Arizona's earliest examples of intellectual property infringement.

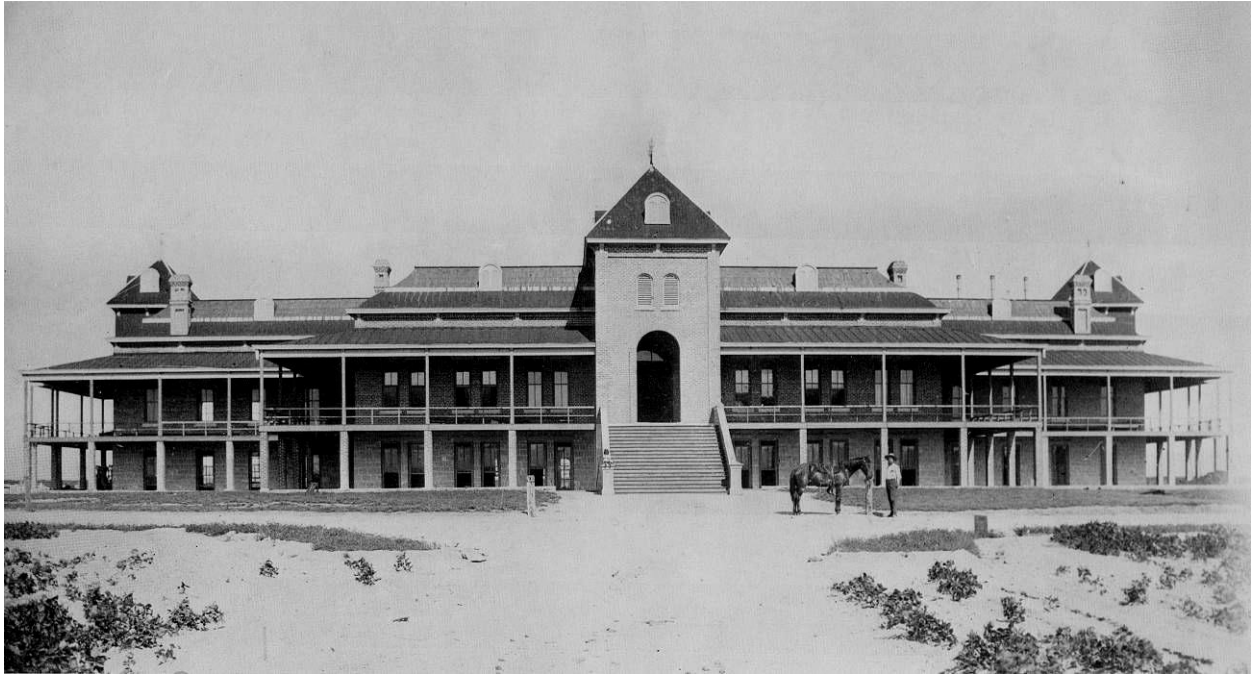
*Figure D - Upon completion in 1891, view looking east. Old Main is Arizona's first passively cooled solar building. The passive cooling system is the 12 ft. deep wrap-around porch providing continuous shade, combined with large double-hung windows on at least two sides of each classroom for cross-ventilation. The windows also provided day-lighting. Heating was provided by fireplaces in each classroom, hence the prominent chimneys on all sides of the building. (Ball, "A Photographic History" title page)*

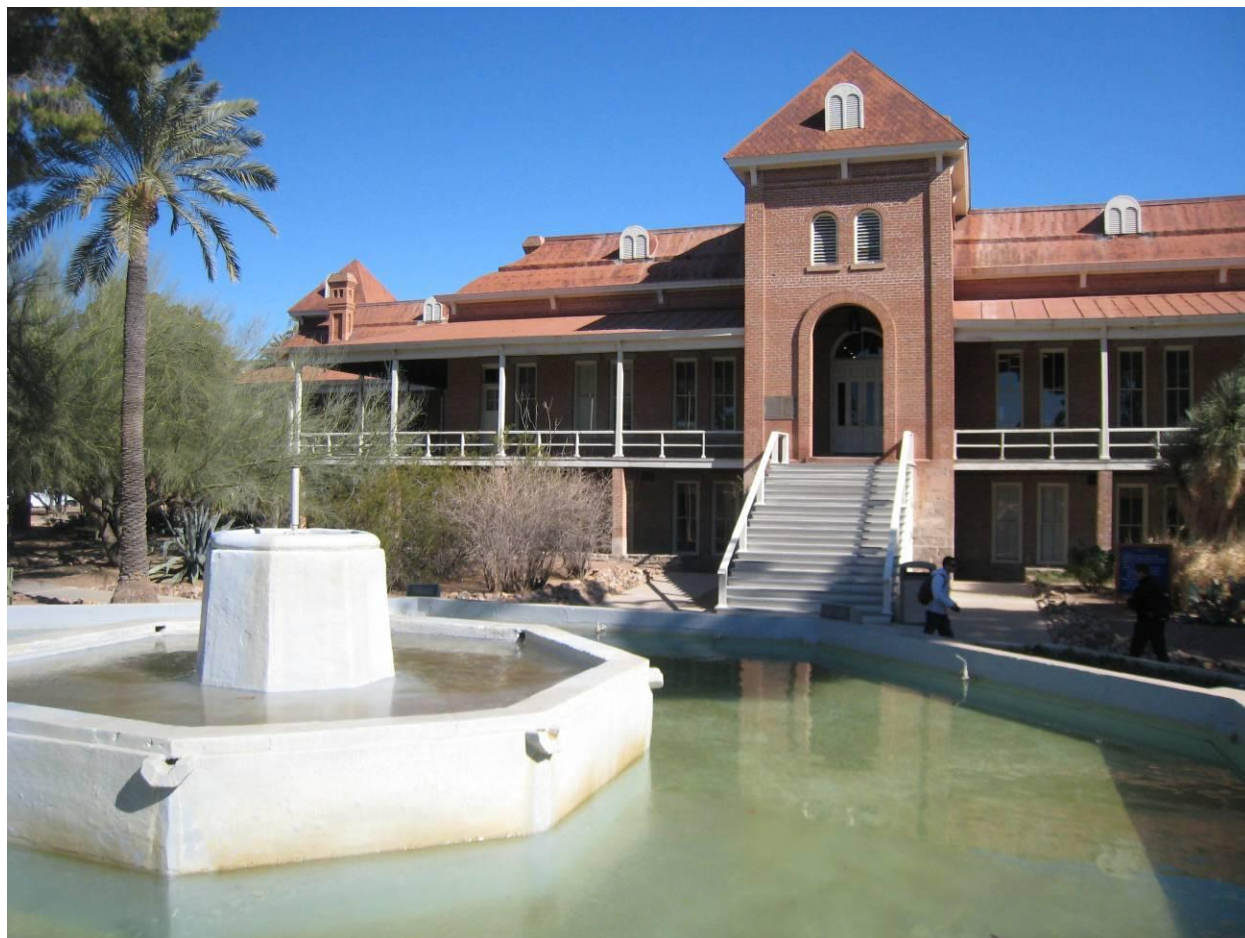
*Figure 1- West façade of Old Main with Memorial Fountain frozen solid, 2/3/11 (B. Vint)*

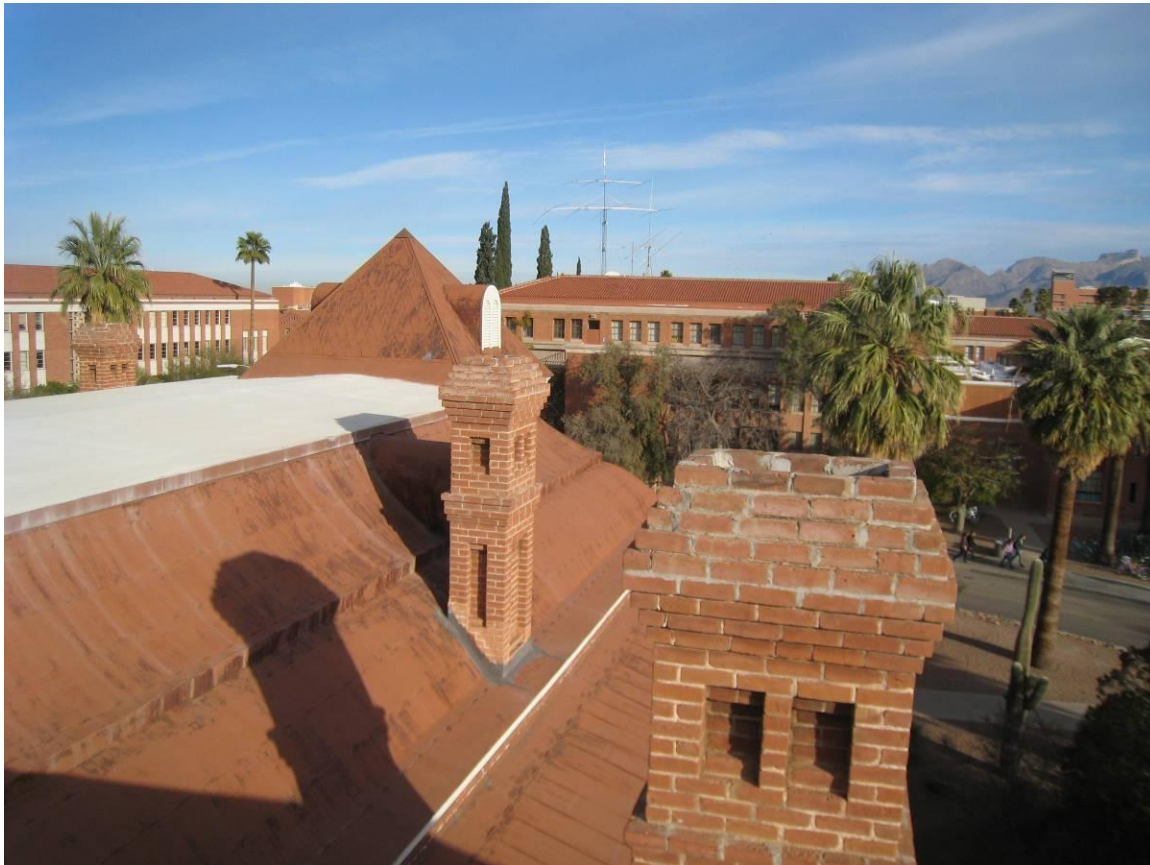
*Figure 2 - East side of roof looking north.(B. Vint, 1/25/11)*

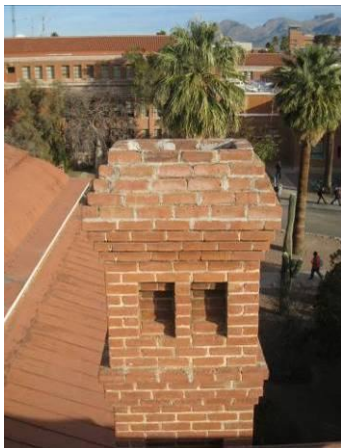
*Figure 3 - Chimney requires re-pointing w/ compatible lime mortar and lateral reinforcing.*

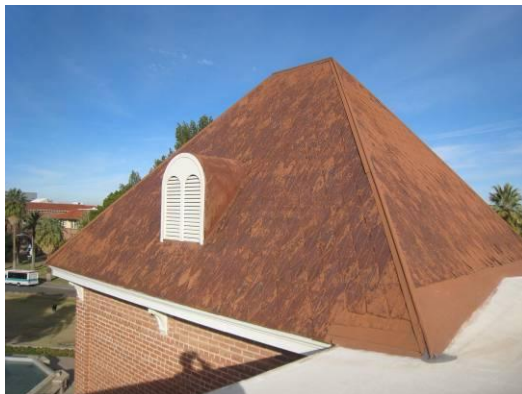
*Figure 4 - Areas of rust and painted repairs at pyramidal roof of west tower.*

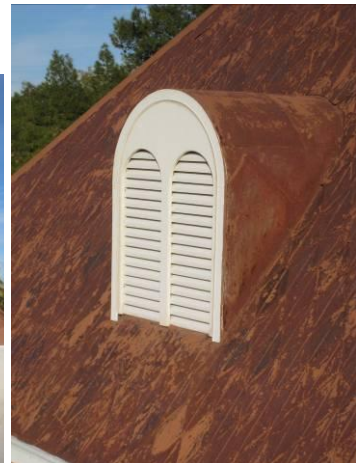
*Figure 5 - Rusted sheet metal roofing at ventilation dormer.*

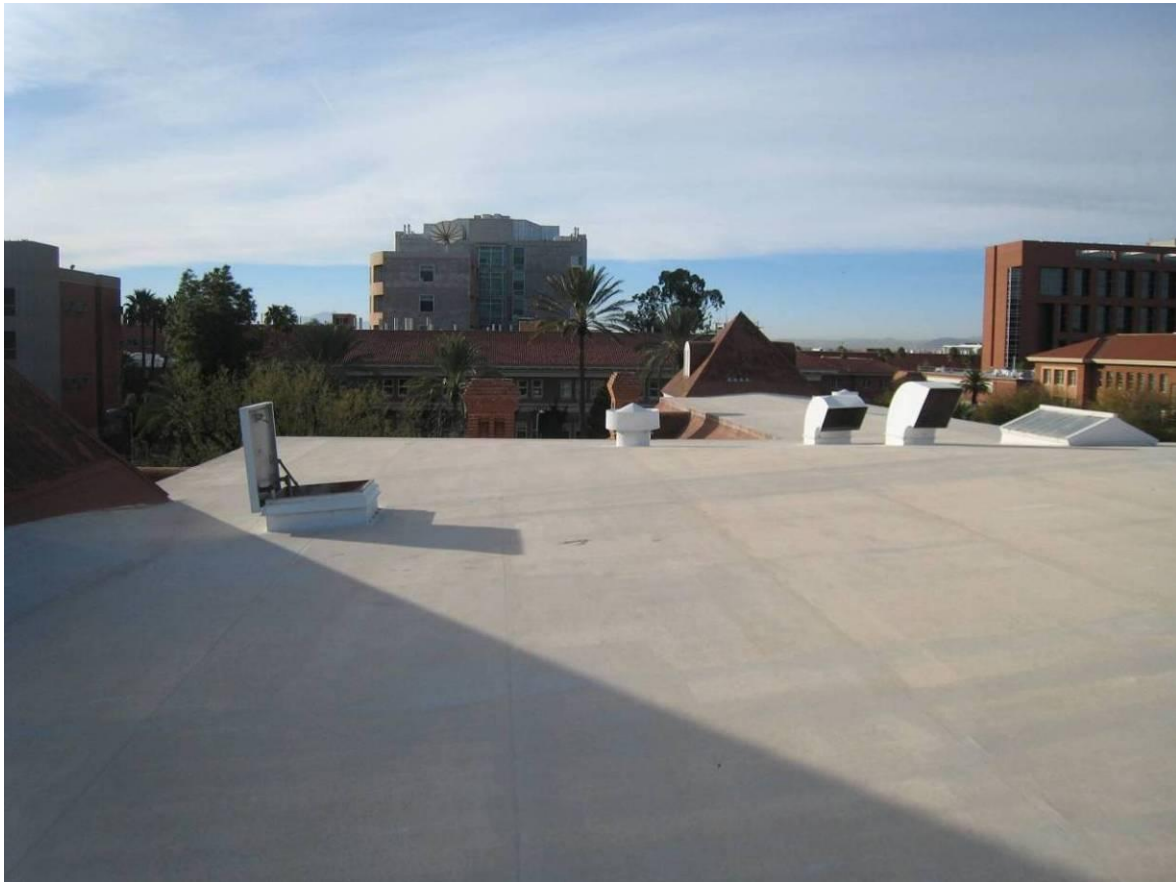
**Figure 6** - Central area recently re-roofed with membrane roofing. This originally was roofed with standing-seam metal in a shallow hipped configuration, as seen in the historic photo on following page.

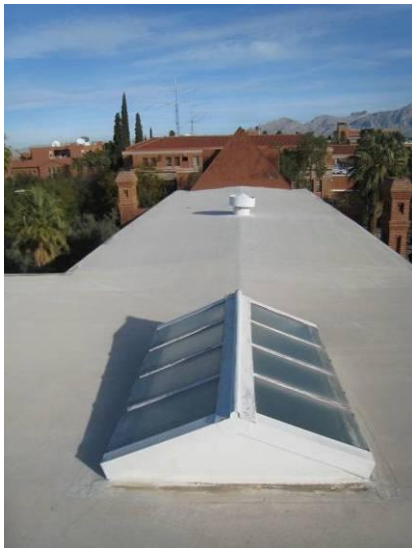
**Figure 7** - North skylight at center of hallway.

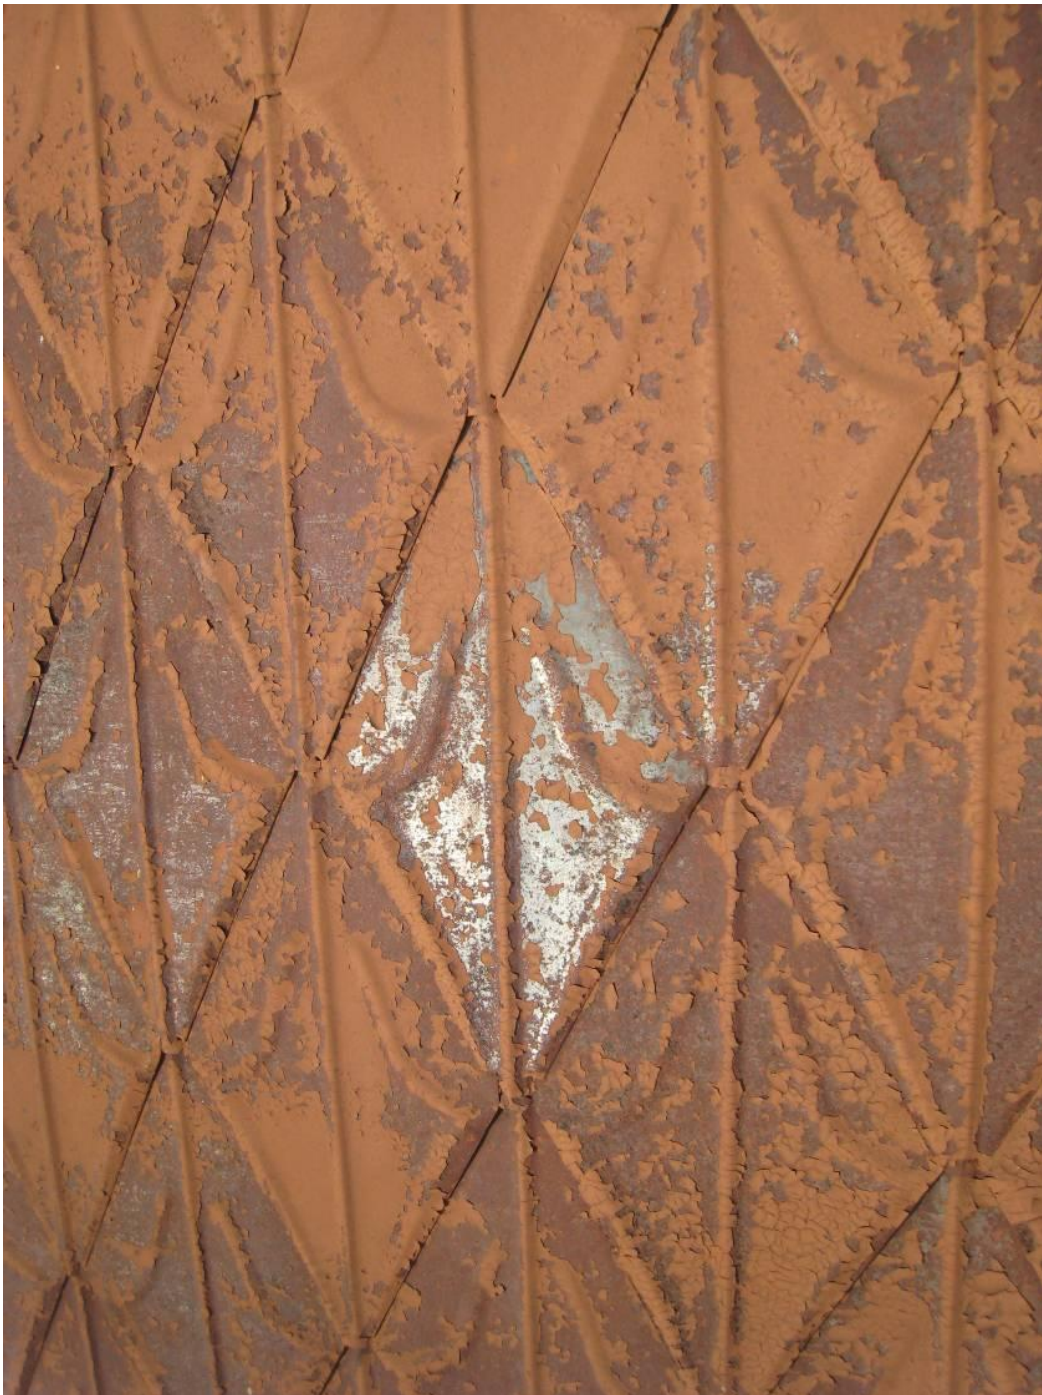
*Figure 10 - Pressed terne-metal fish scale shingles used at 4 tower roofs and as wall siding at north & south towers. Severe deterioration is evident. Paint disguised deterioration and prolonged life.*

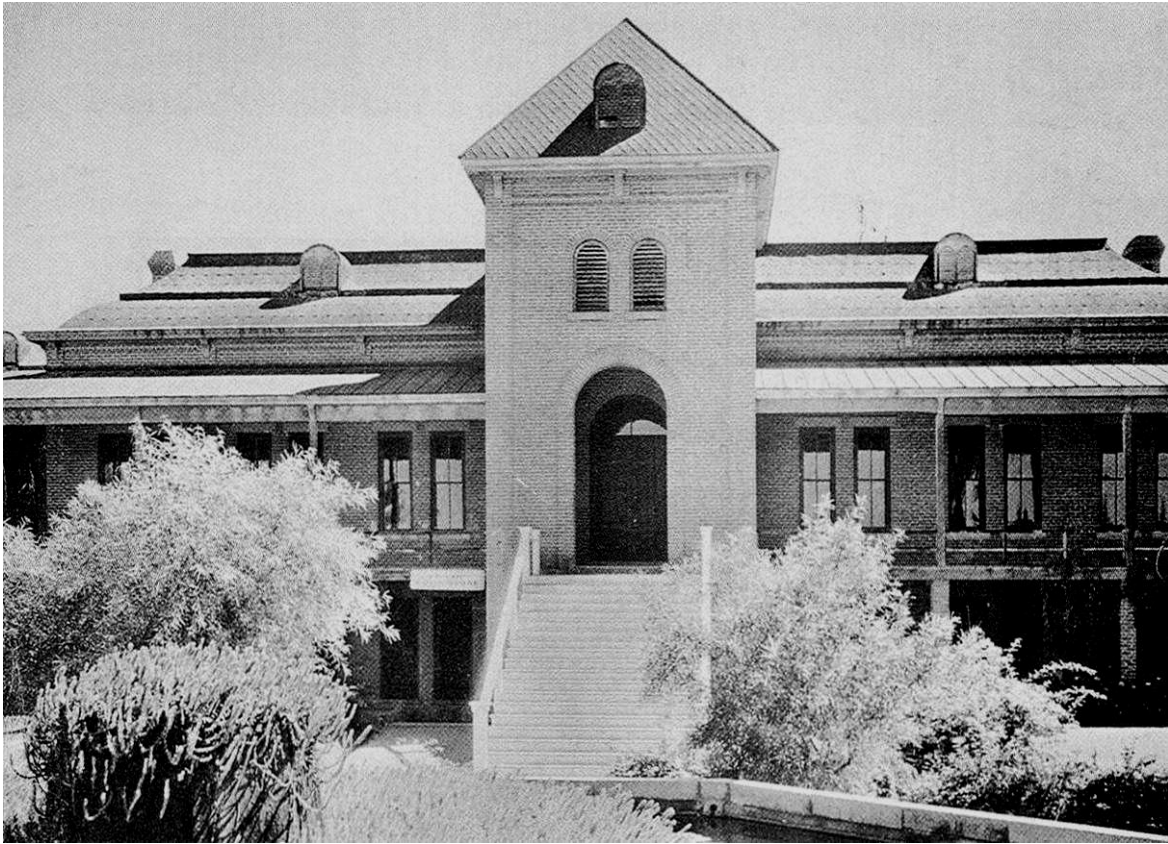
*Figure O - West elevation 1938 with Memorial Fountain in foreground overgrown with vegetation. Note weathered and dilapidated appearance of building with pieces missing from wood louvers at ventilation dormers. According to the National Register nomination this was the year that the City of Tucson condemned Old Main as unsafe and University administrators considered demolition. Finials & weathervanes missing from peak of west tower.*

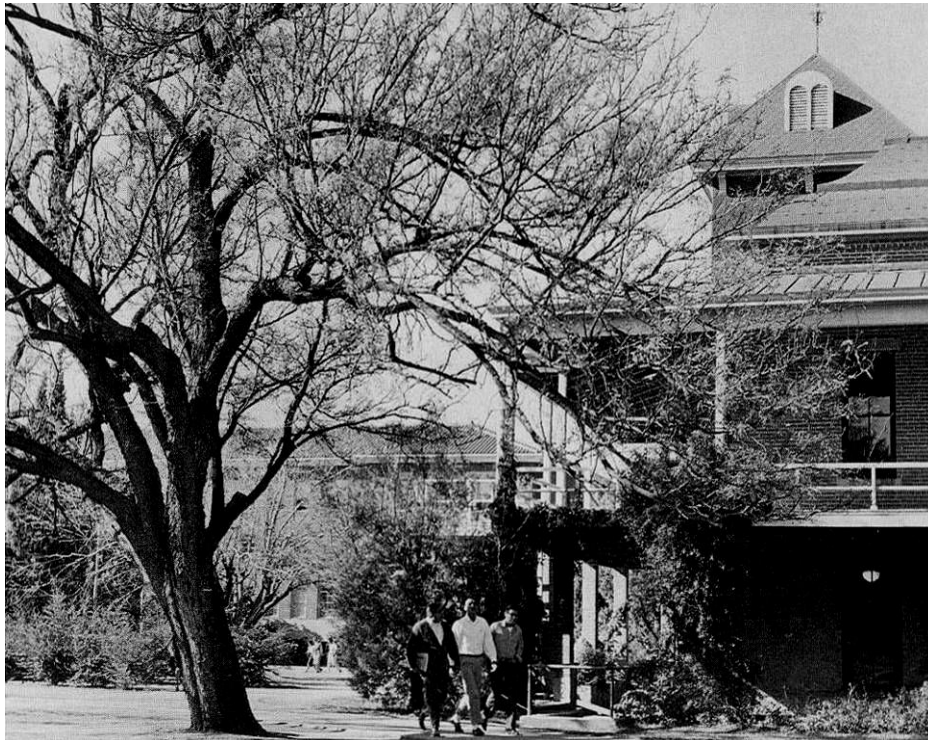
*Figure P- SE corner in 1966; standing seam porch roof, note original finial/vane still in place at tower, upper right.*

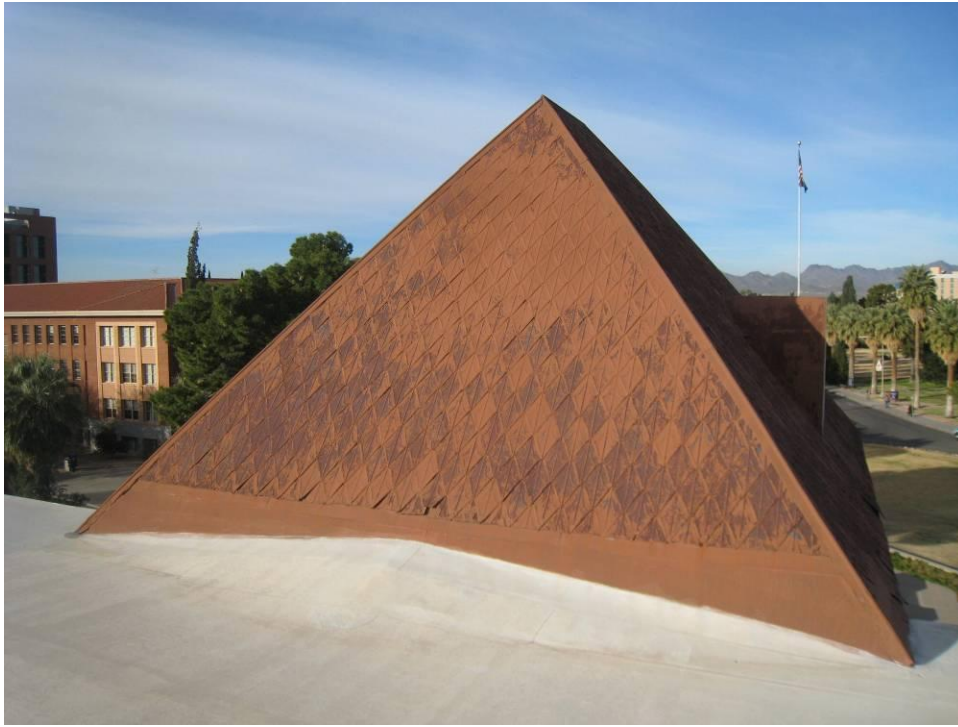
*Figure 13 - Pyramidal roof of West tower; original finial and weathervane is missing.*

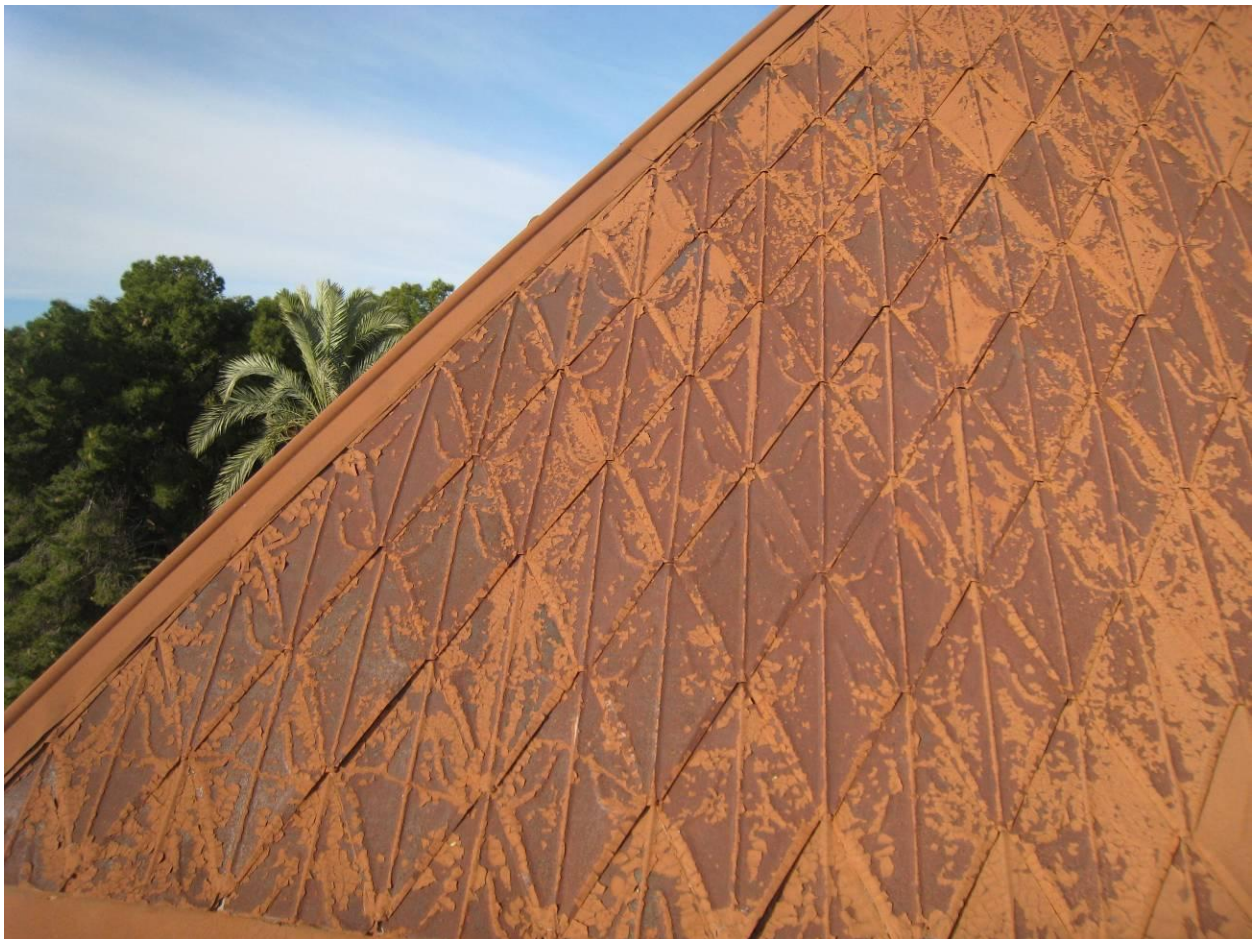
*Figure 14 - Detail of terne-metal 'fish scale' roof tiles at West tower.*

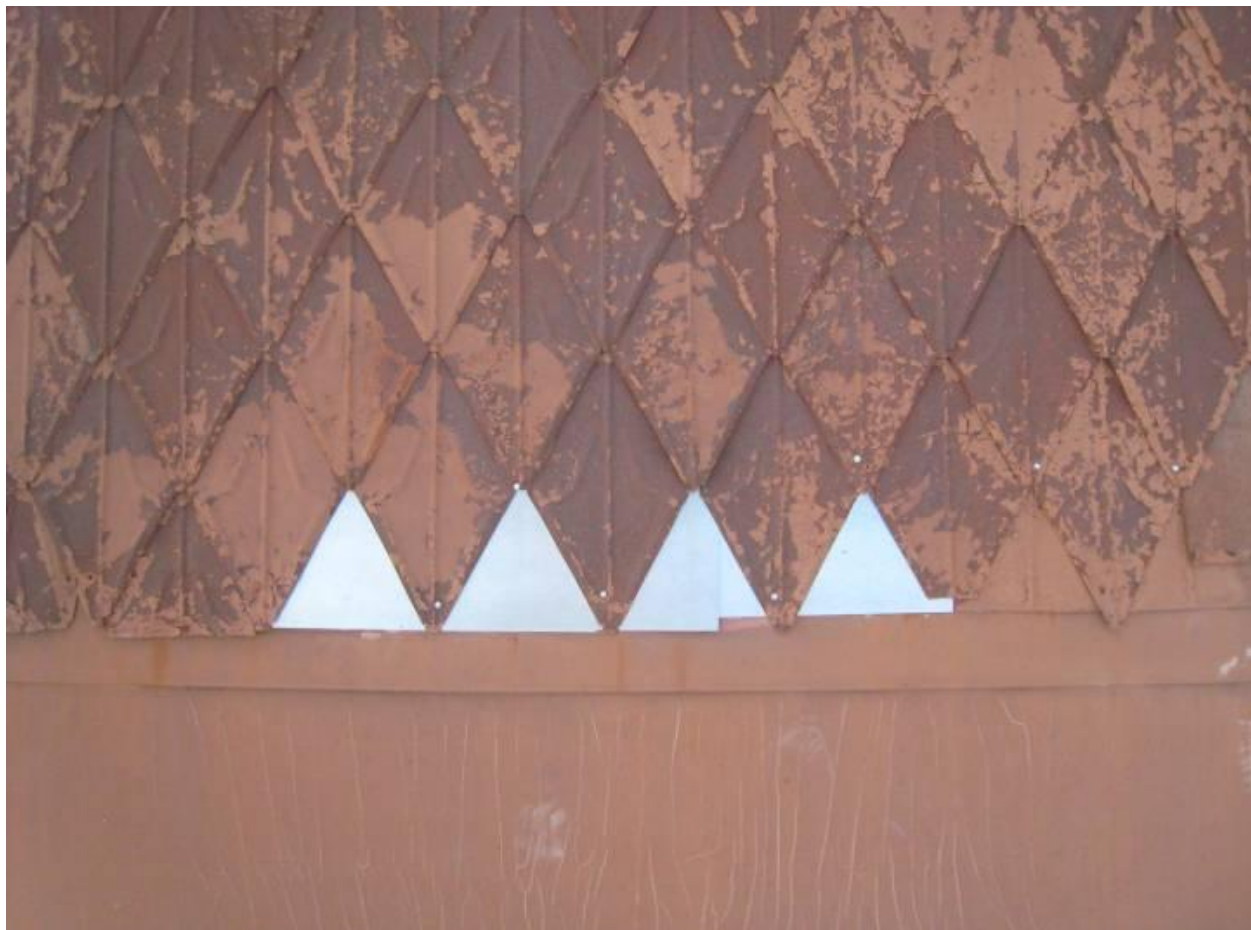
**Figure 16** - Details of pressed/stamped terne-metal shingles original to building (1891); Arizona’s oldest roofing. Provisional repairs made w/galvanized sheet metal at north face of south tower (hence in shade).

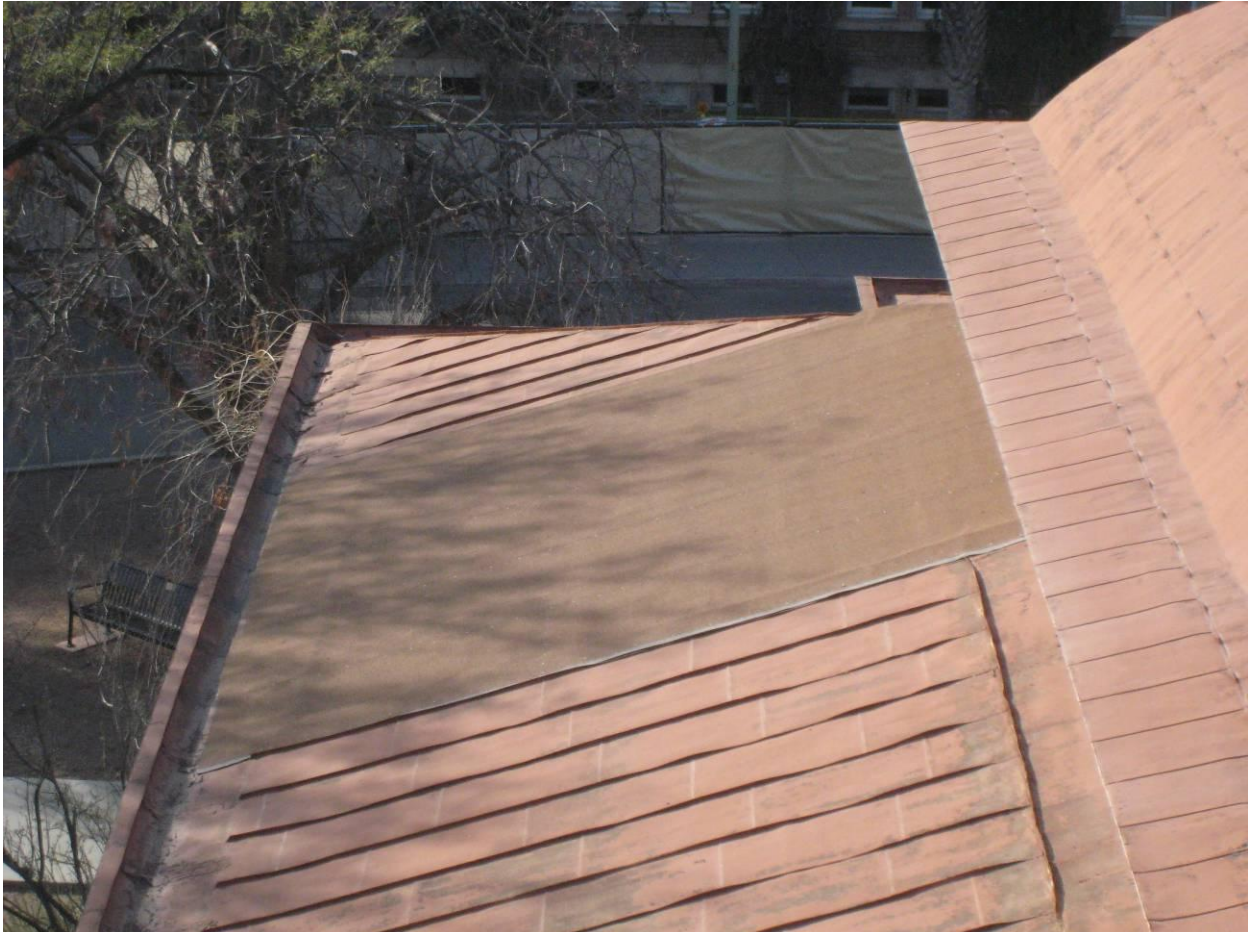
*Figure 17- SE wing of porch with deteriorated standing seam metal, a portion of which has been replaced with patch of asphalt roll-roofing with brown mineral cap. Note shallowness of perimeter gutter, which is ineffective.*

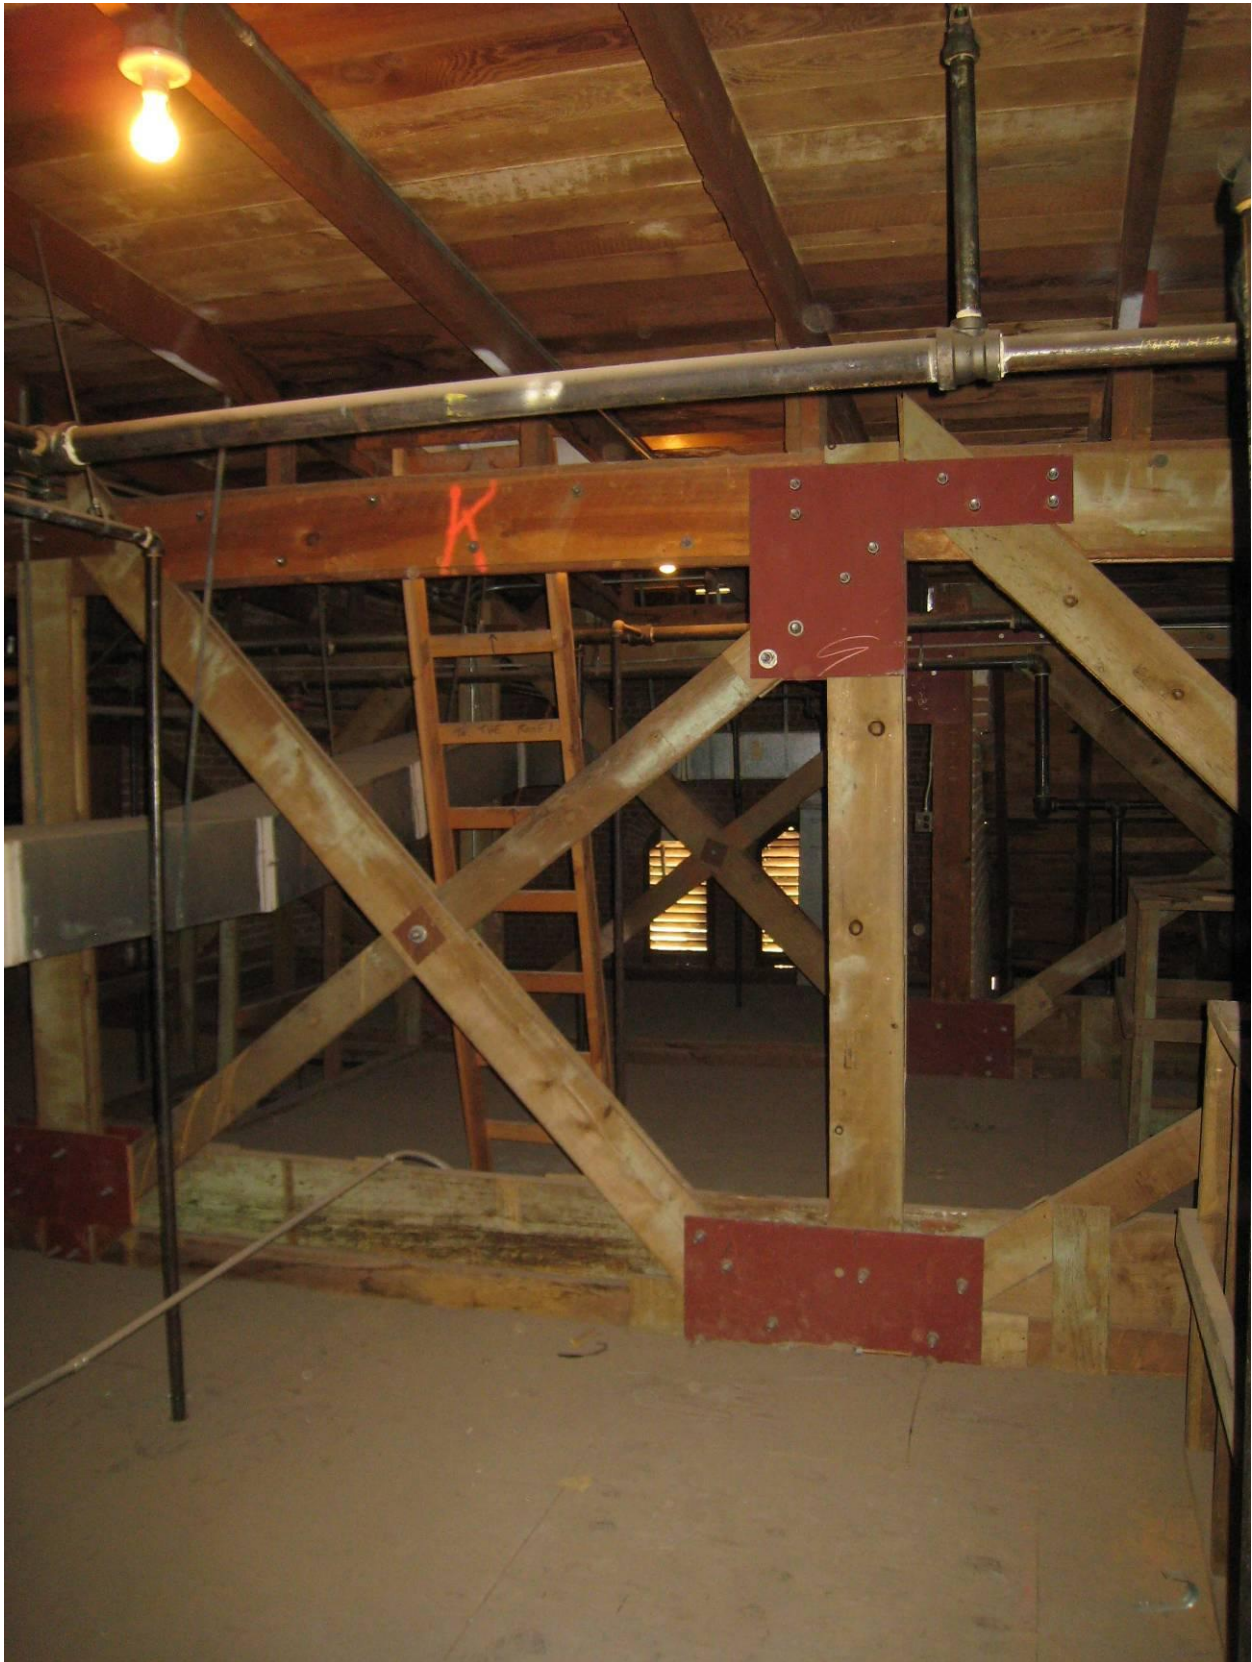
*Figure 20 - View of typical truss at center section; note secondary roof joists propped from top chord for slope, and numerous repairs made to trusses over time. Despite apparently haphazard nature of repairs, structure is well tied together and presently stable. Duct at left of photo runs to east tower ceiling for air intake.*

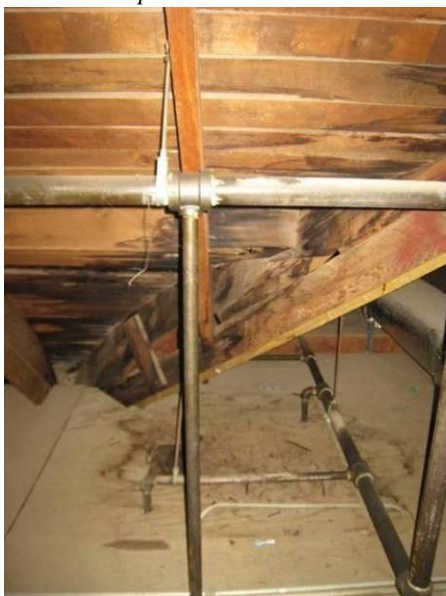
*Figure 23 - Roof leaks at valleys and hips have damaged wood framing over time.*

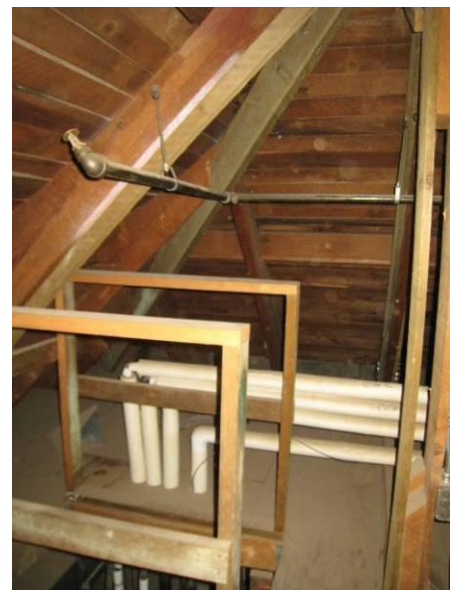
*Figure 24 - Hip rafter adjacent replaced w/pressure treated 2x6 (note green tint)*

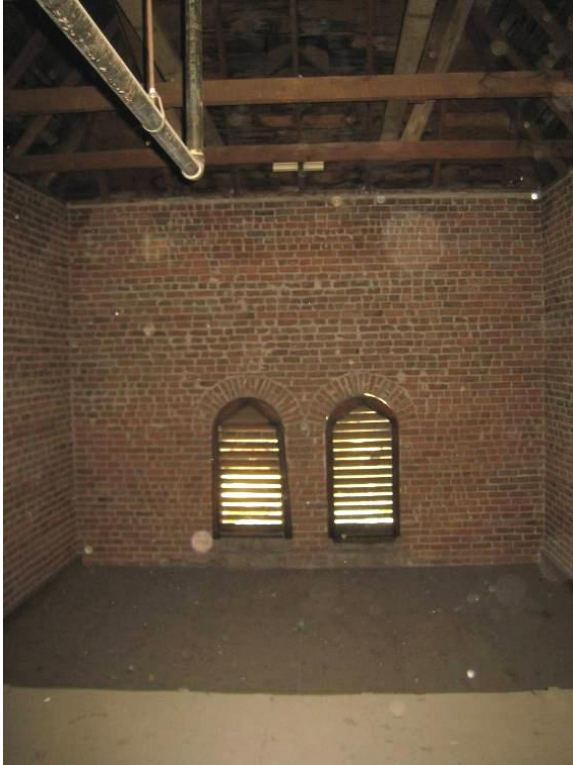
The north and south tower roofs are true pyramids in shape, with 4 equal slopes meeting at a single point. They are framed with full 2x4s @ 32" OC, supported on wood frame bearing walls composed of 2x4s @ 32" OC, sheathed with 1x4 plank type decking.

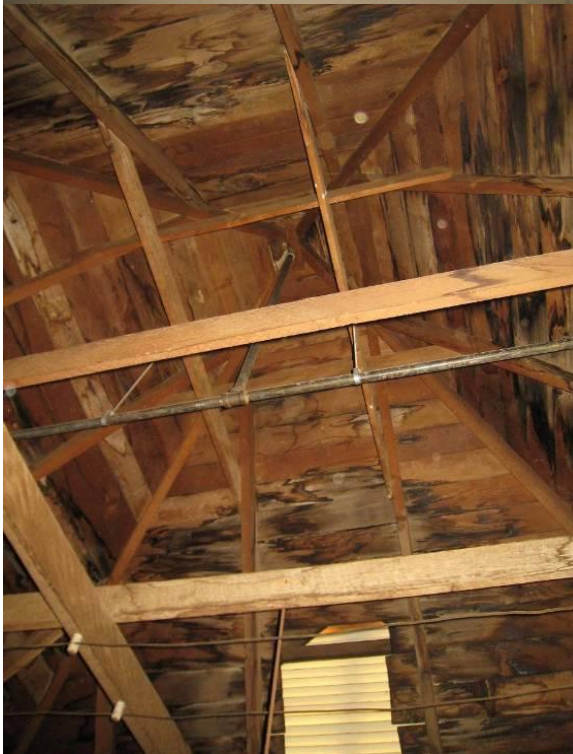
**Figure 27** - Interior of south tower pyramid; extensive leaking is evident. Roofing must be replaced as well as 1x6 wood deck affected by moisture. At the towers, approximately 50% of decking appears moisture-damaged. At time of re-roofing, plywood or OSB sheathing should be installed above 1x6 decking, to create a diaphragm for improved lateral stiffness.

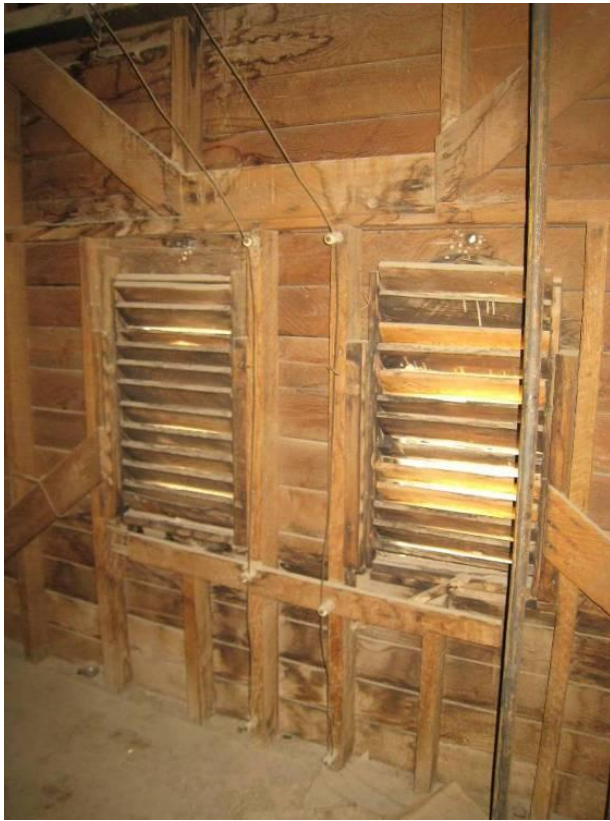
**Figure 28** - Interior of south tower (north is similar). Wall framed with full 2x4 studs with diagonal 1x6 bracing and horizontal 1x6 sheathing. Exterior finish is diamond-shaped terne-metal shingles, installed directly to sheathing without a vapor barrier (it's possible that a vapor barrier, if it was asphalt building paper, may have disintegrated over the 120 year life of Old Main). Wood frame north and south towers are not weather-tight; wind, dust and rain penetrate space. Louvers lack bird & insect screens.

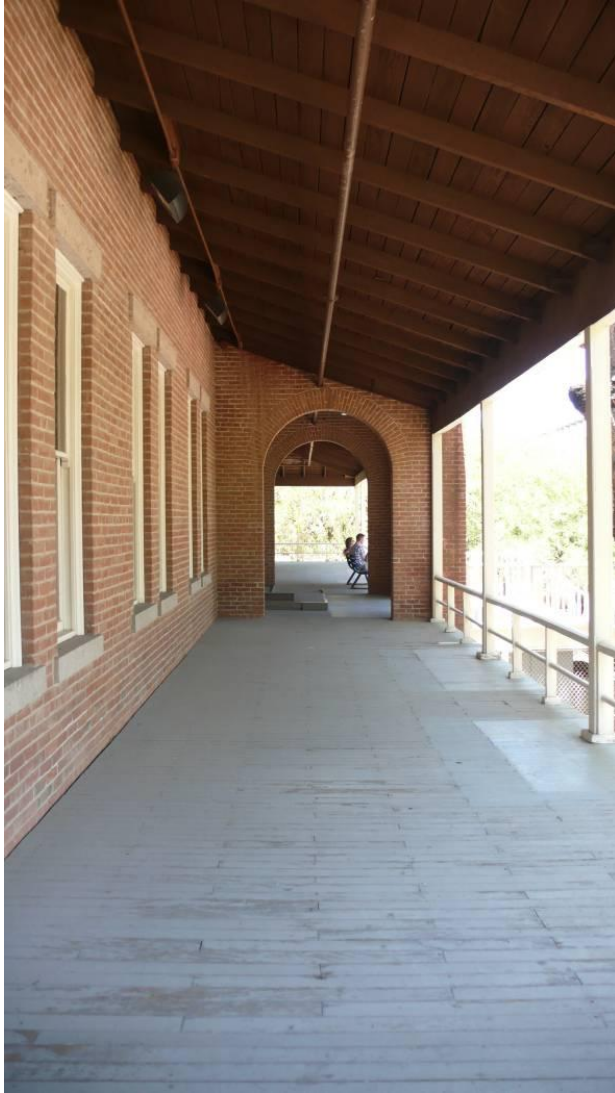
### (3) PORCH ROOF STRUCTURE:

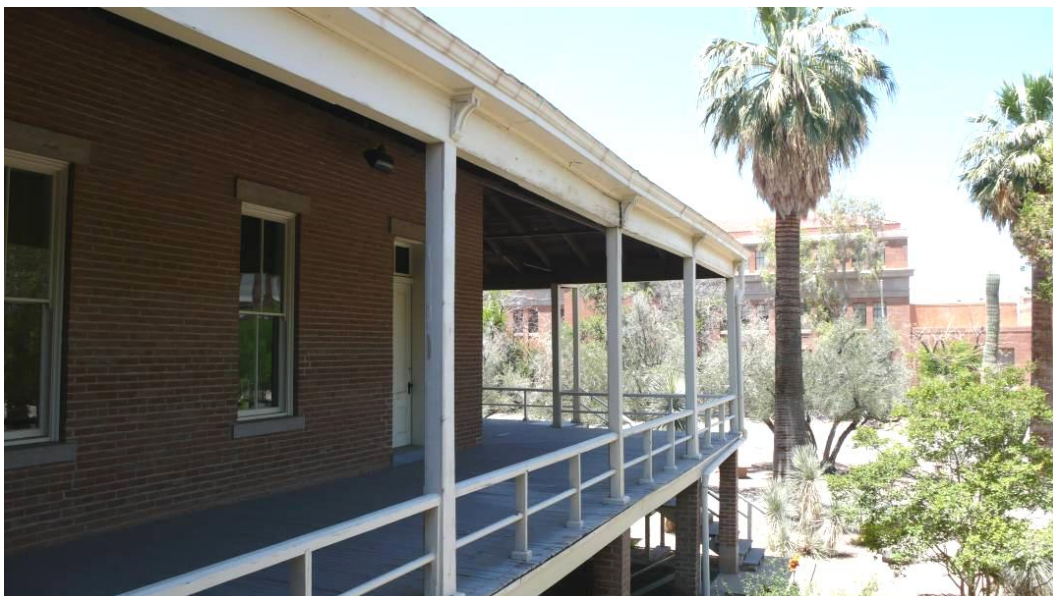
*Figure 31 - Perimeter beam at post #9 (second from left) shows deterioration & settlement; this may be due to foundation settlement rather than failure of the beam itself.*

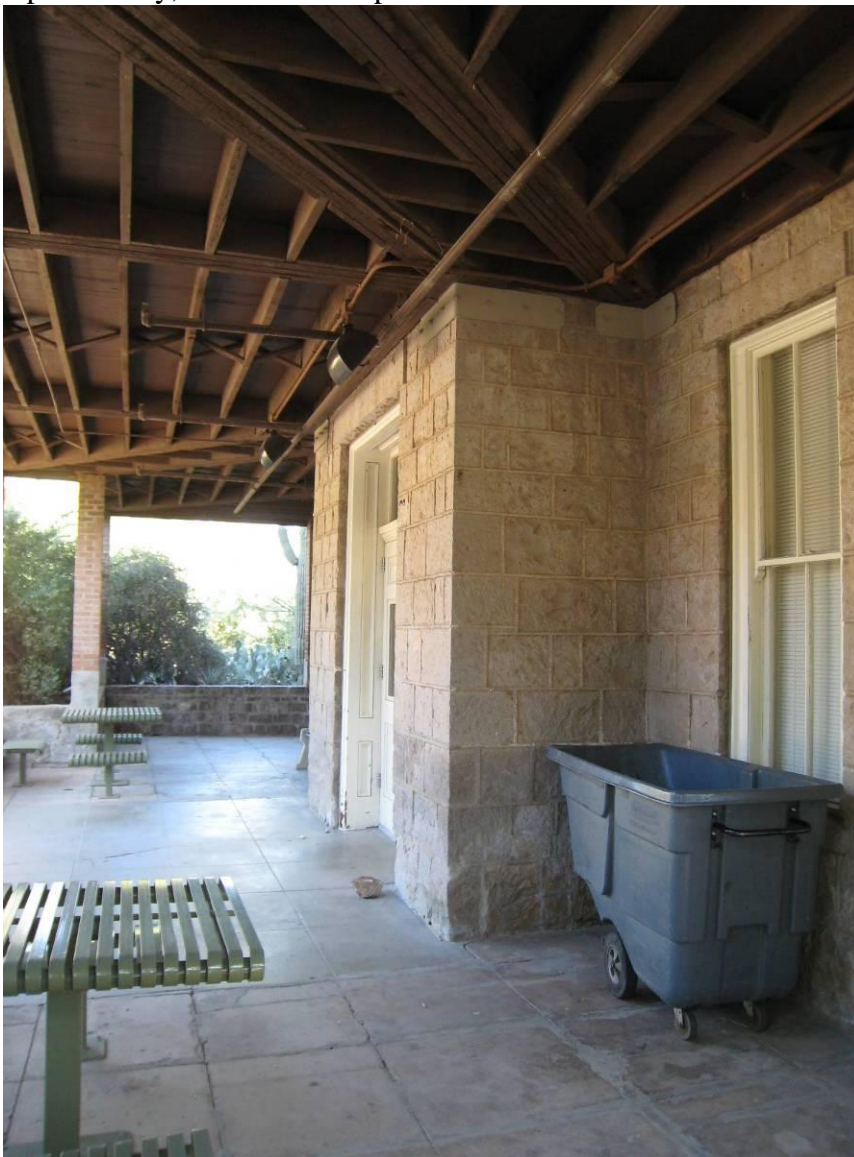
*Figure 32- Porch floor structure; decking has deteriorated and joists are rotted.*
