PRESERVATION MASTER PLAN  
FOR  
**OLD MAIN**  
*University of Arizona*  
*Tucson*  
1891~2011

*Designed by James M. Creighton, Architect, 1887*  
*Constructed by M. J. Sullivan, Builder, 1887-1891*

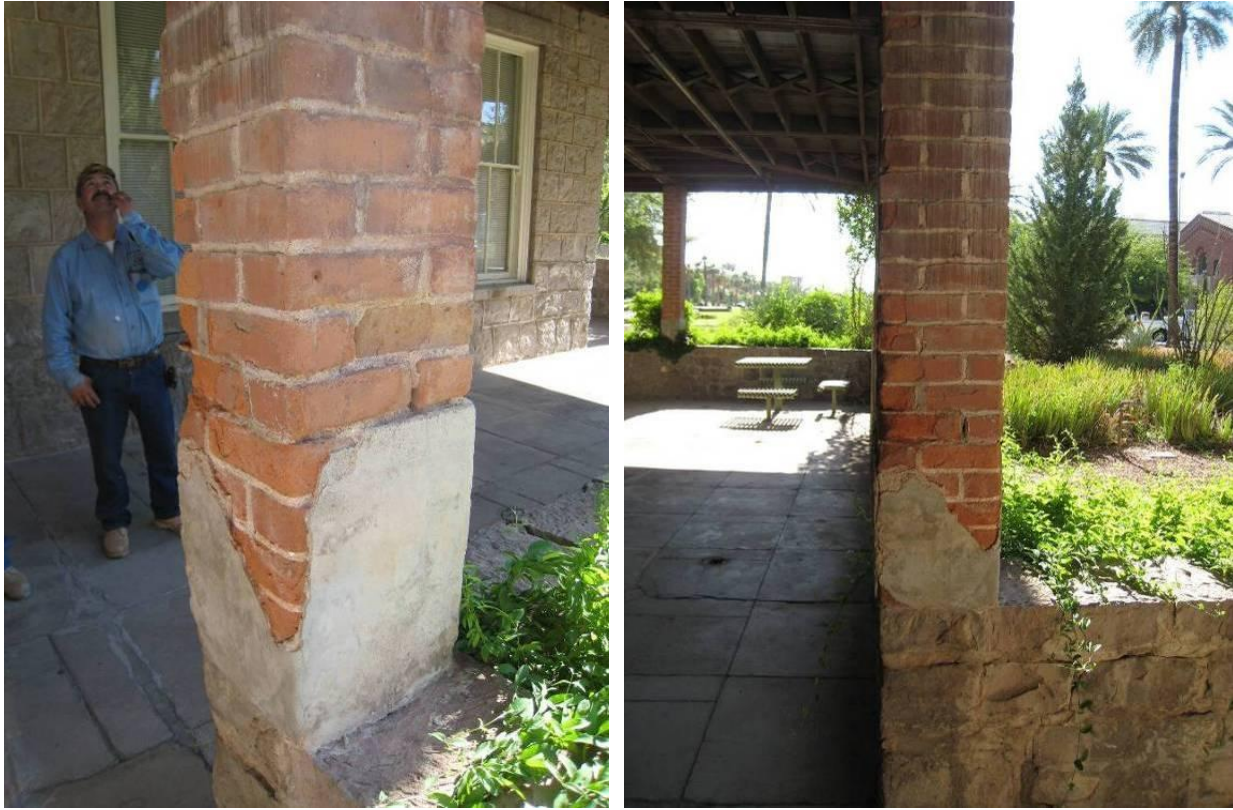
*Figure 33- Pier #50 at SE corner of porch. The brick has been seriously eroded by the action of water and salts.*

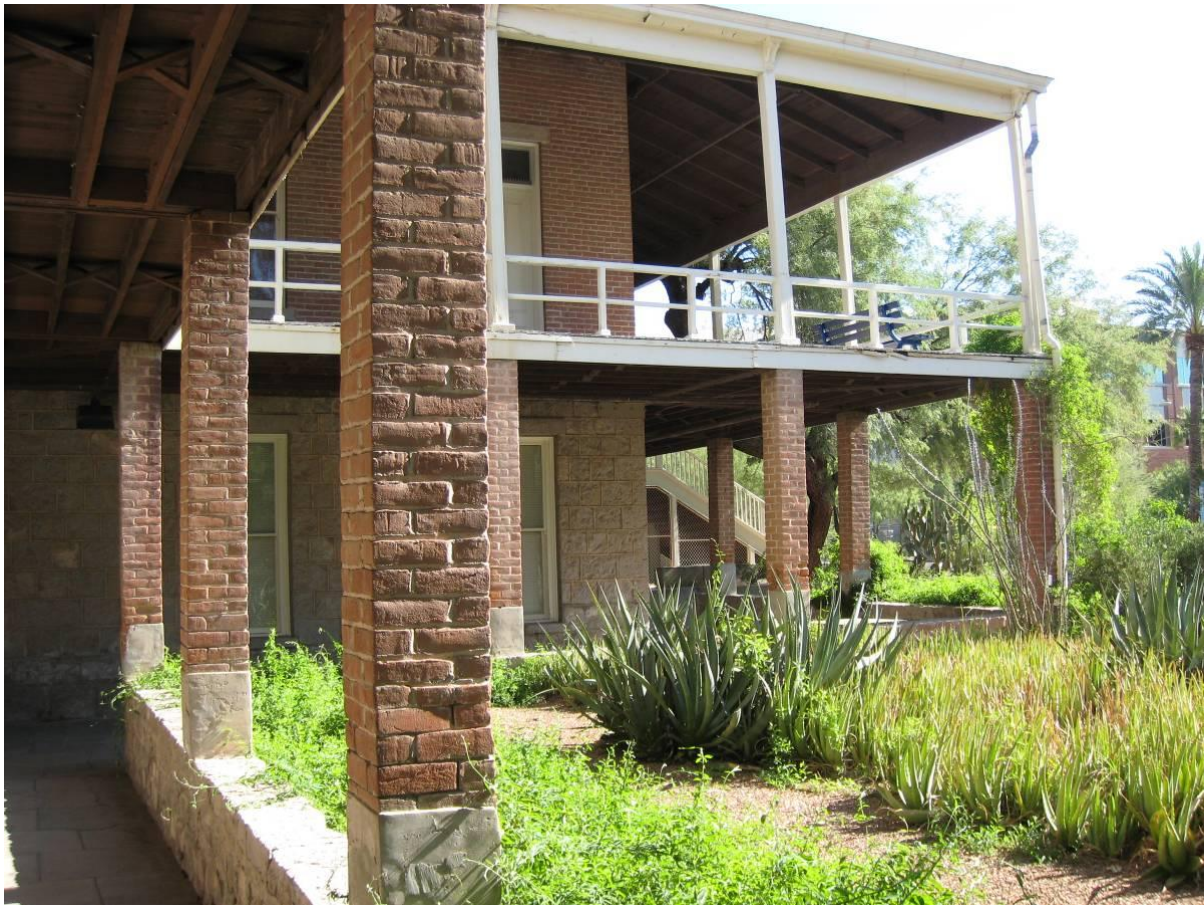
*Figure 34 A. – Vines and ground cover are picturesque and cool, but very bad for the building. Irrigated or non-native plants within 5 ft. of structure should be removed. Only native desert plants should be used near foundations.*

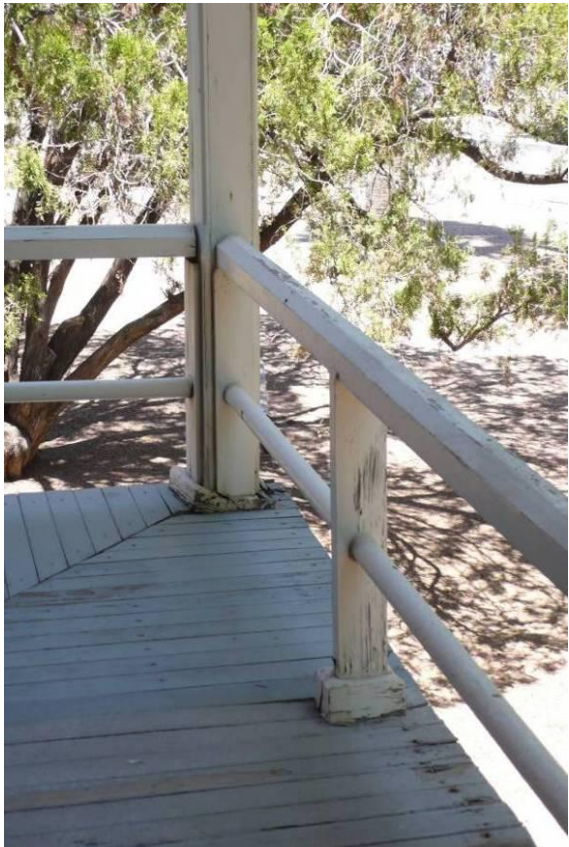
*Figure 36 - Deteriorated deck & base at post # 11.*

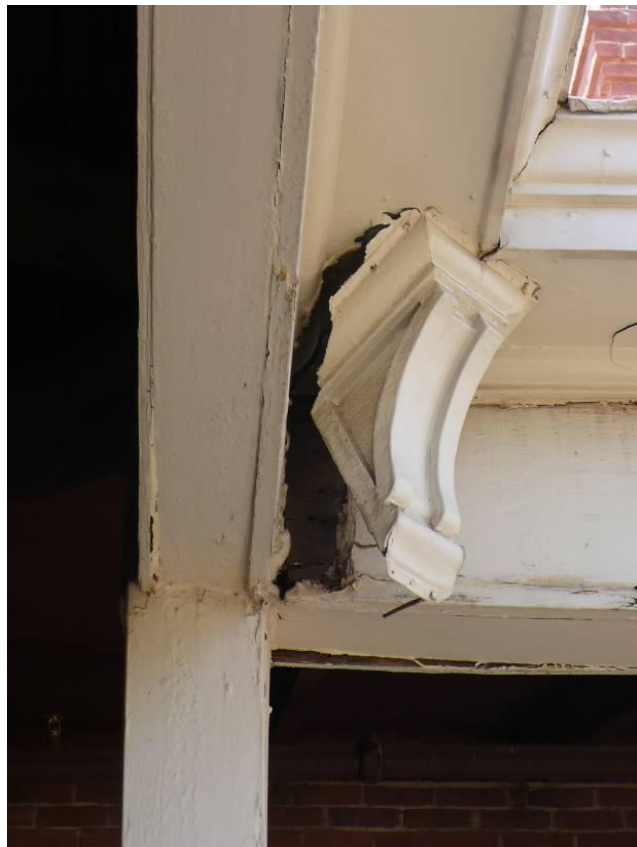
*Figure 37 - Deteriorated wood & sheet metal bracket at post #7.*

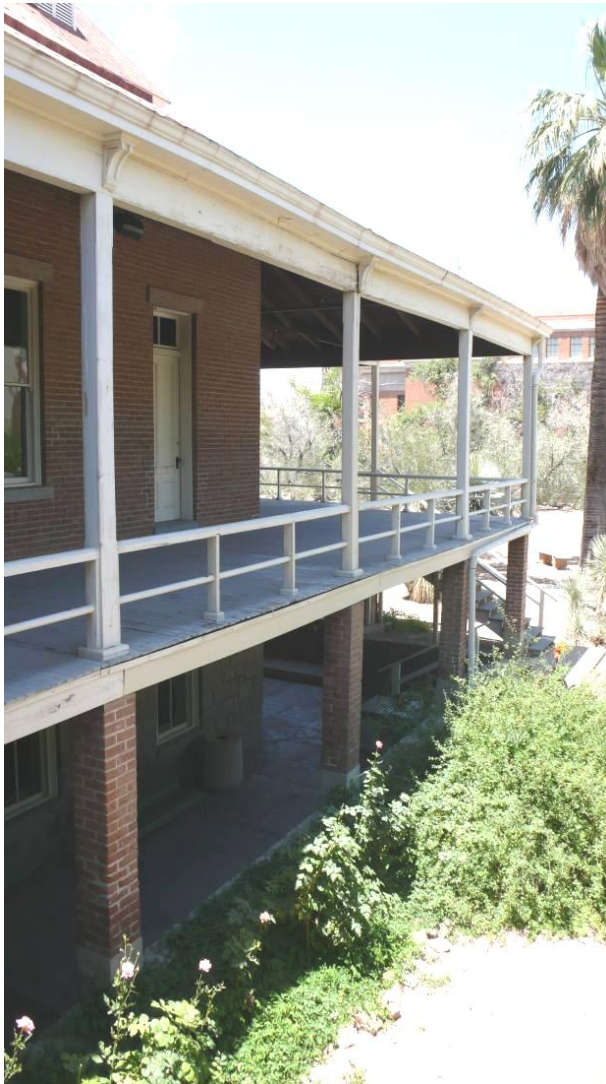
**Figure 38** - North east porch from pier #8 to pier #11 note differential settlements at pier #9, as indicated by deflection in eave line.

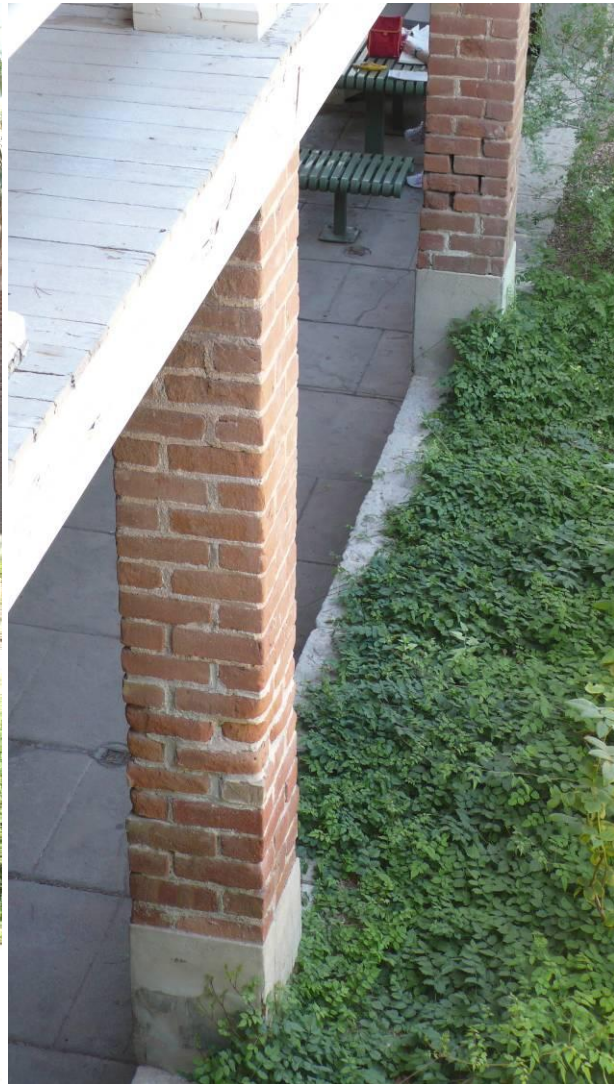
**Figure 39** - Piers # 8 & 9 have rising dampness to a height of 6 ft. above floor level. Water-loving plants near building attract & hold moisture. It is advisable to remove all such plants for the long-term health & stability of the historic structure.

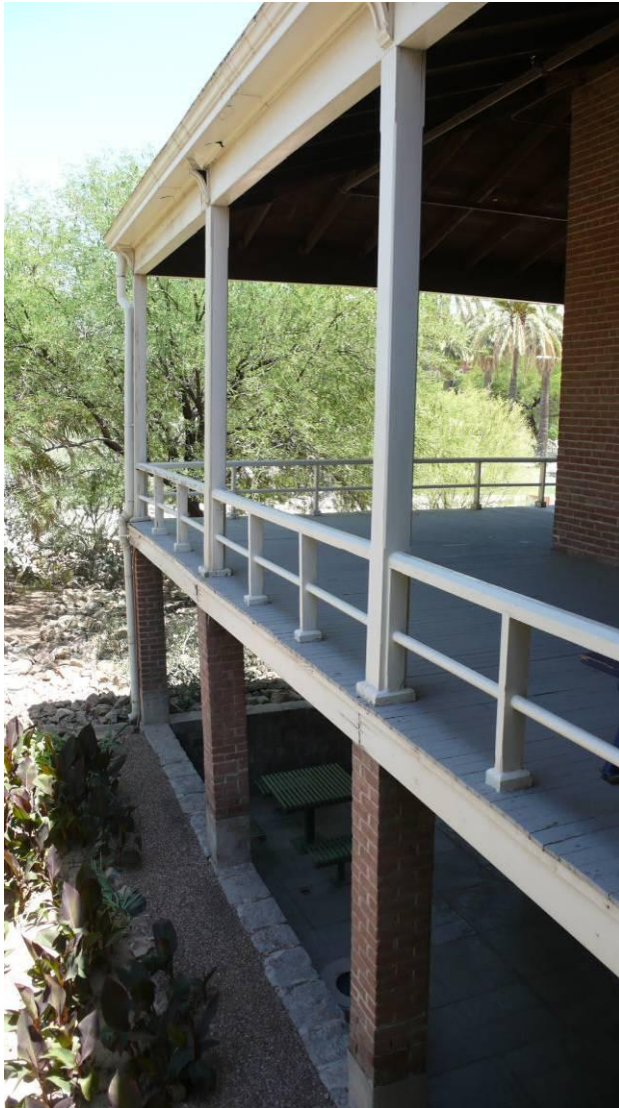
**Figure 40** - Porch piers & posts significantly out of plumb; piers #5 & #6 at NE corner of east wing.

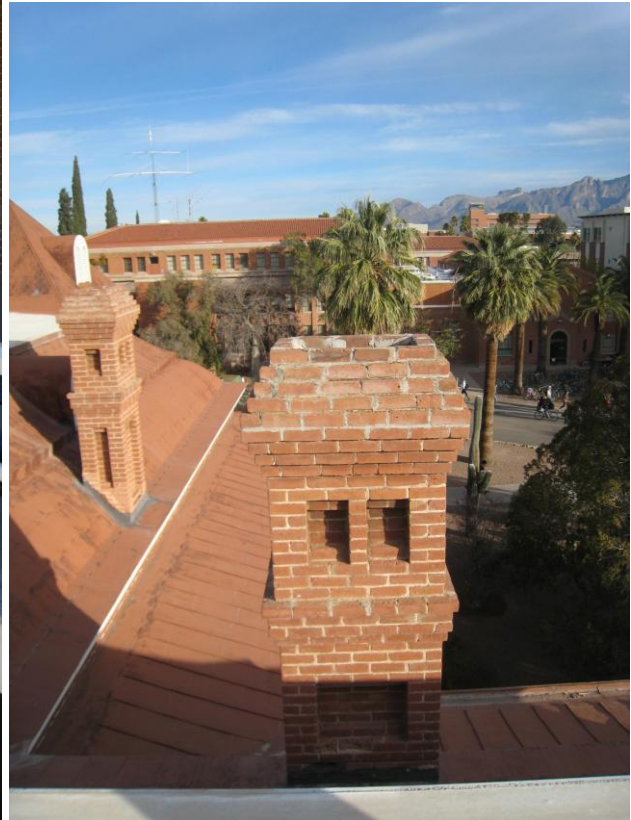
**Figure 41** – Old Main has eight un-reinforced brick chimneys, vulnerable to earthquake forces. Such exposed features are also vulnerable to lightning.

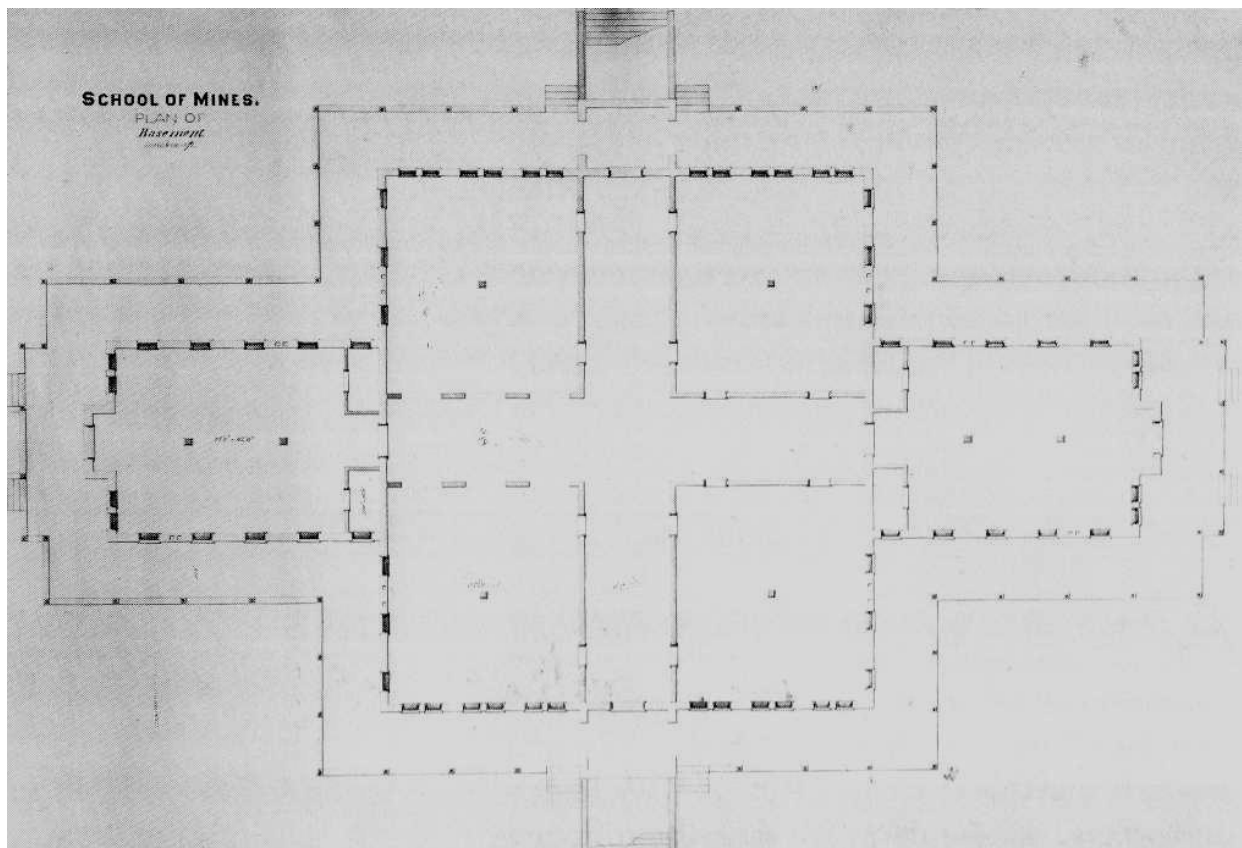
**Figure R** - Original plan of Old Main displays Classical symmetry & simplicity. Regularity of bearing walls is evident. Symmetrical plan is an advantage with regard to lateral forces, as symmetrical buildings perform better under wind or earthquake loads than do asymmetrical ones.

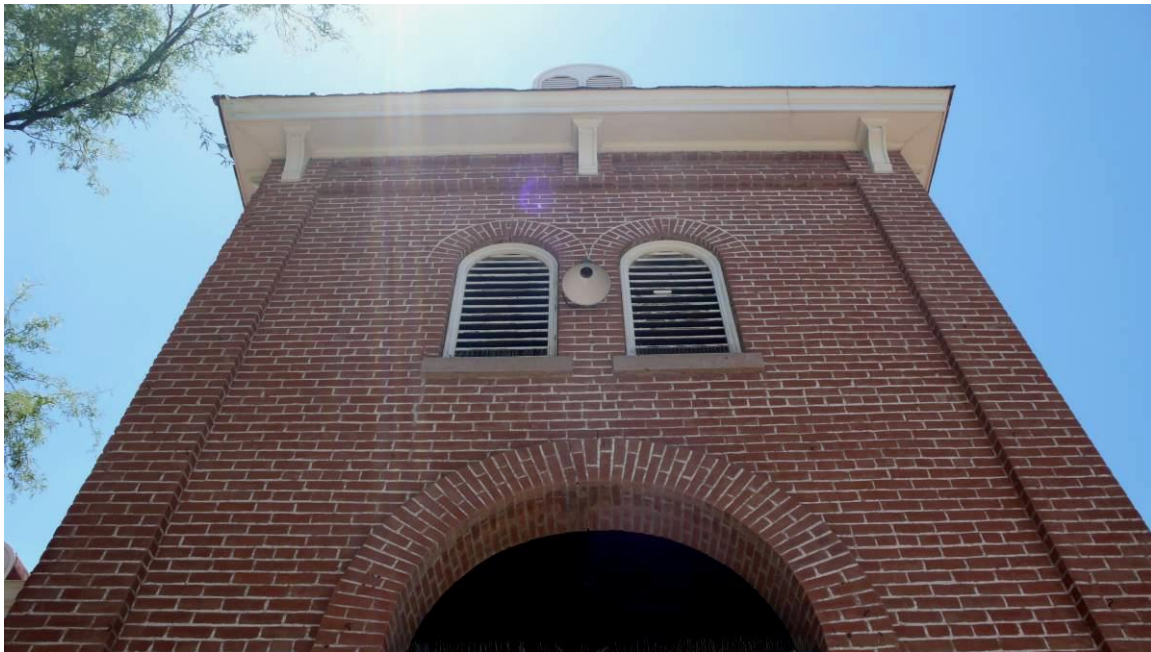
**Figure 42** - East wall of east tower: cracks at key-stones of arches at entry towers, east & west. These will require re-pointing

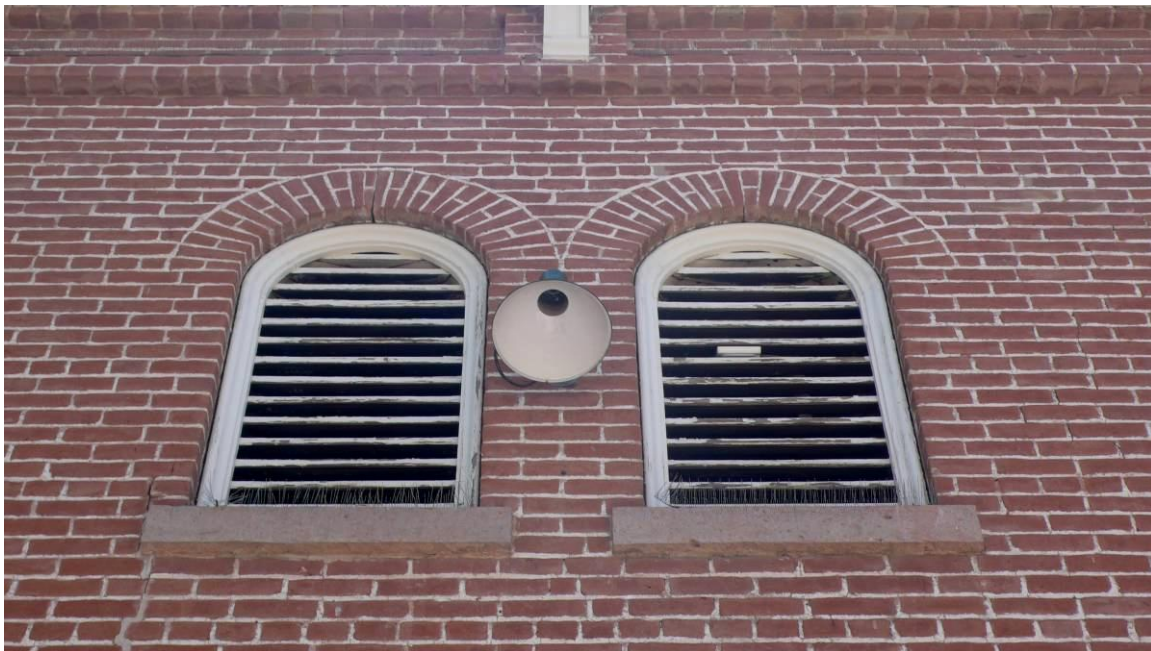
**Figure 43** - Shear cracks through brick at left side of sill of left-hand arch at east tower should be monitored.

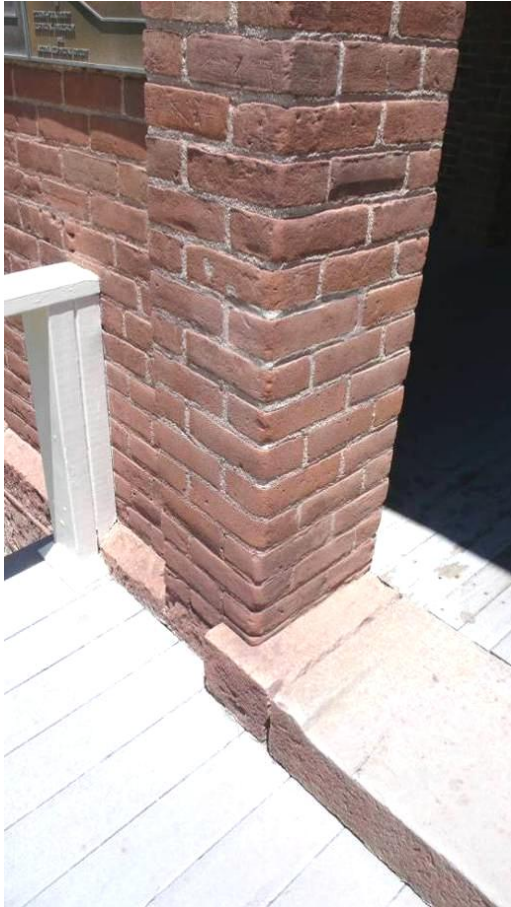
*Figure 44 - Worn brick and threshold stone at west tower.*

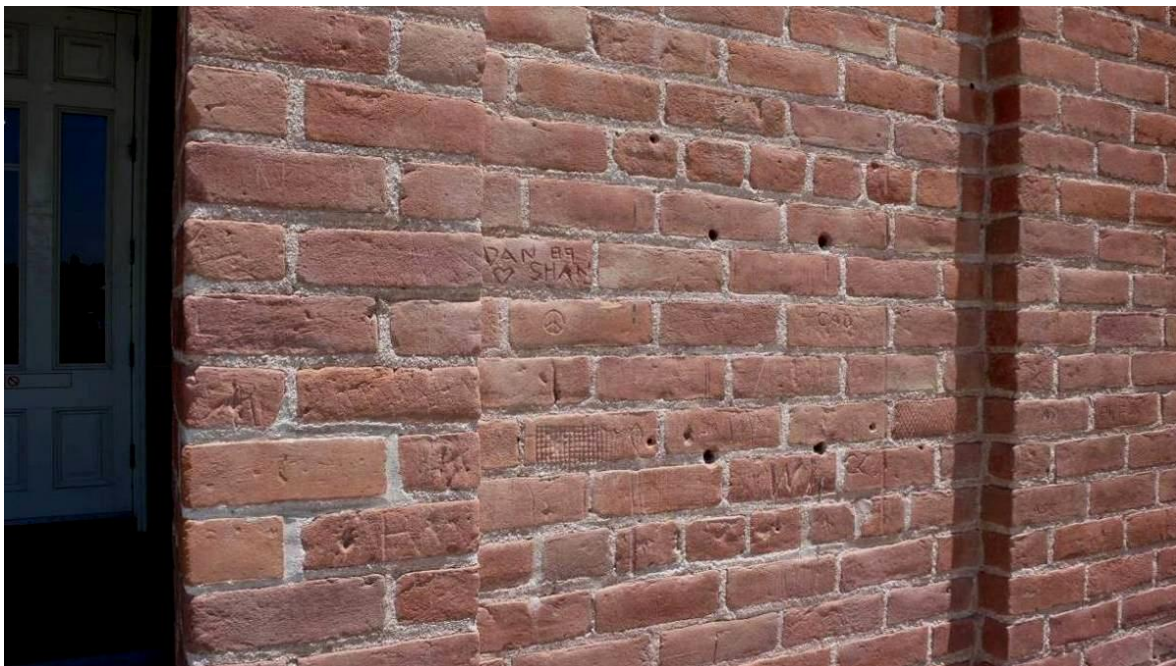
*Figure 45 - Brick worn smooth where people come in contact with it, brushing by or carving graffiti in the surface.*

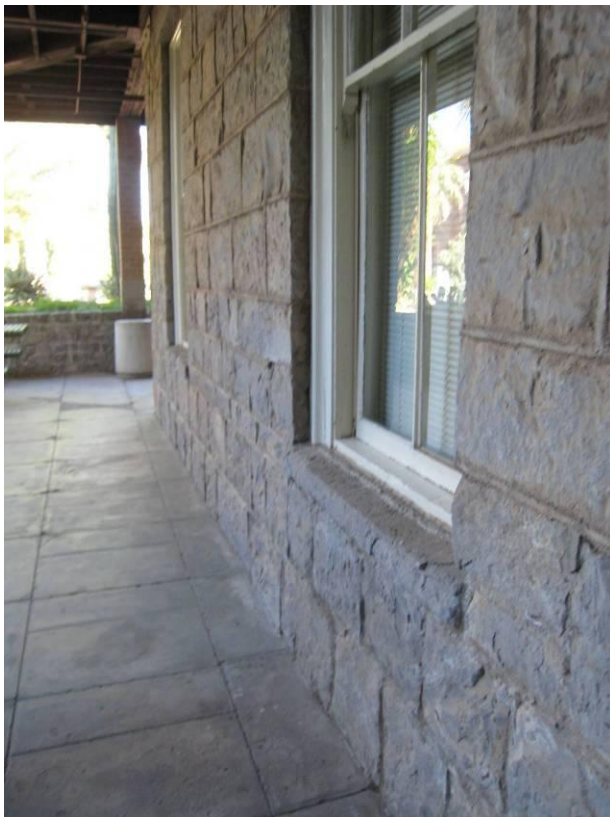
**Figure 46** - The level to which moisture rises is evident in the discoloration of stone in the lower section of the wall, up to and above the sill level. Two-thirds of the sills at the 1st floor (40 out of 60 ) are deteriorated through salt erosion and must be replaced .

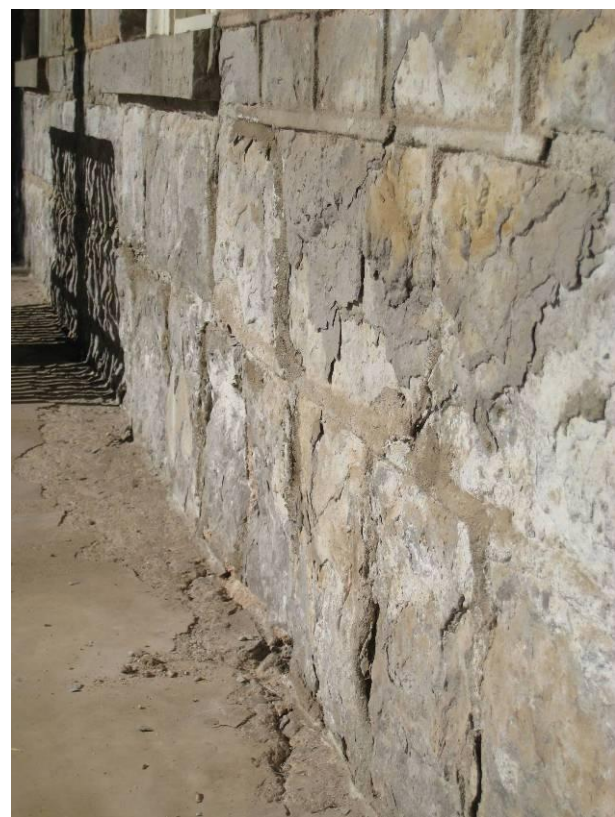
**Figure 47** - “*Pietra infirma*” (sick stone) must be removed and substituted with new stone of compatible strength & geologic composition, to the depth of the deterioration. Cement repairs must also be removed.

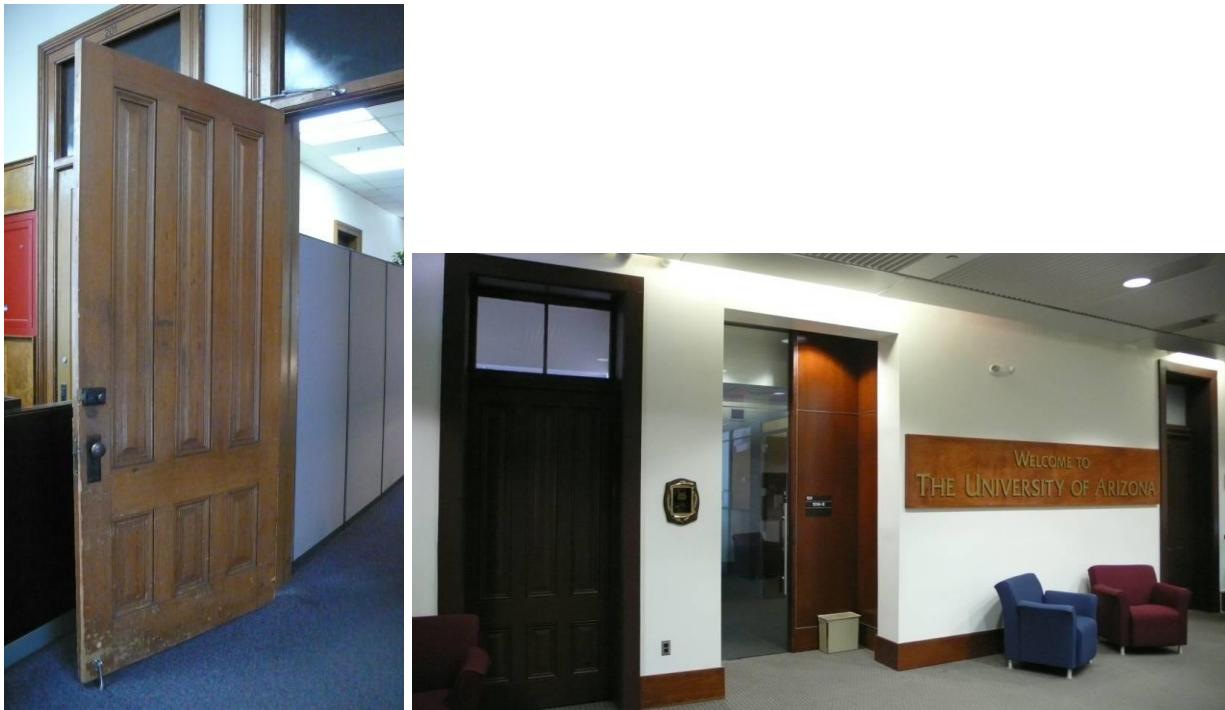
*Figure 48 - Original wood panel doors survive at 2nd floor (left); at 1st Floor, historic doors have been fixed in place and painted; a new tempered glass door has been cut through the historic brick wall beside it to give access to new offices in a former classroom.*

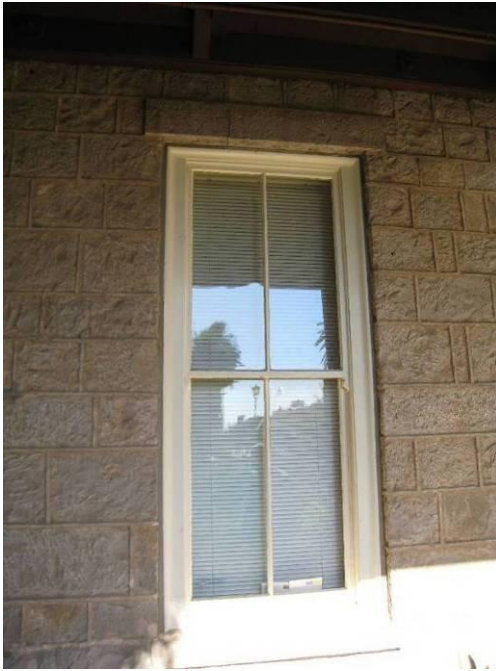
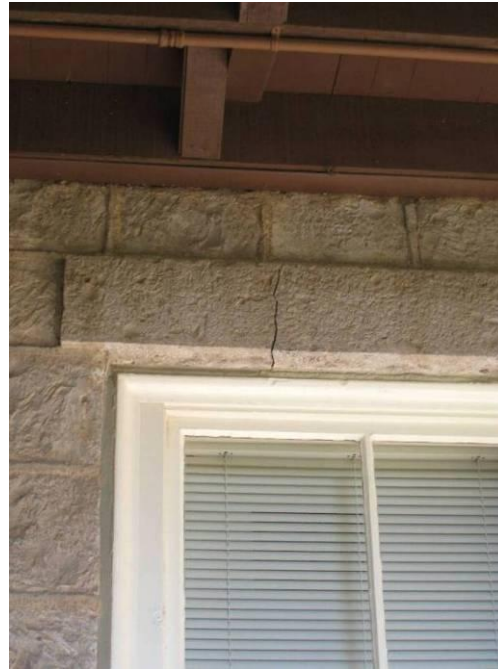
*Fig. 49 - DH wood sash window with float glass. Fig. 50 - Cracked stone lintel at SE corner.*

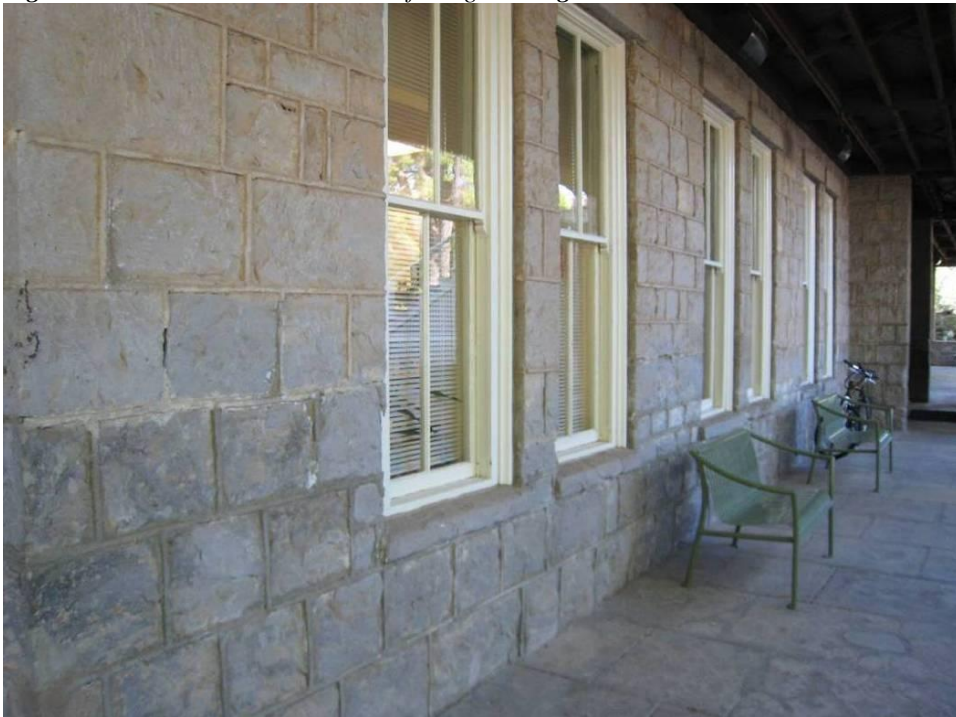
*Figure 51 - East wall of first floor displays discoloration to height of rising damp in stone.*

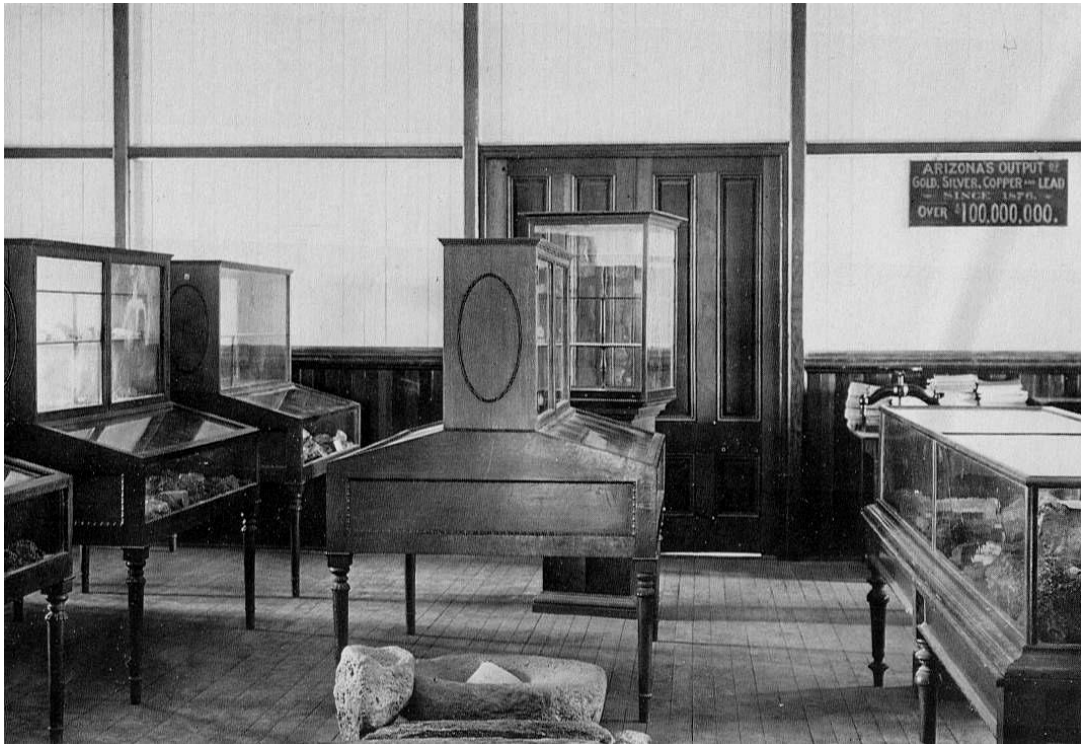
**Figure S-** Territorial Museum at 2<sup>nd</sup> floor of Old Main, 1899. Note wood floor (1 x 4, likely fir), wood wainscot and partition, also vertical proportions of wood panel door. Sign at right reads: ARIZONA'S OUTPUT IN GOLD, SILVER, COPPER AND LEAD ~ SINCE 1876 ~ OVER \$100,000,000.

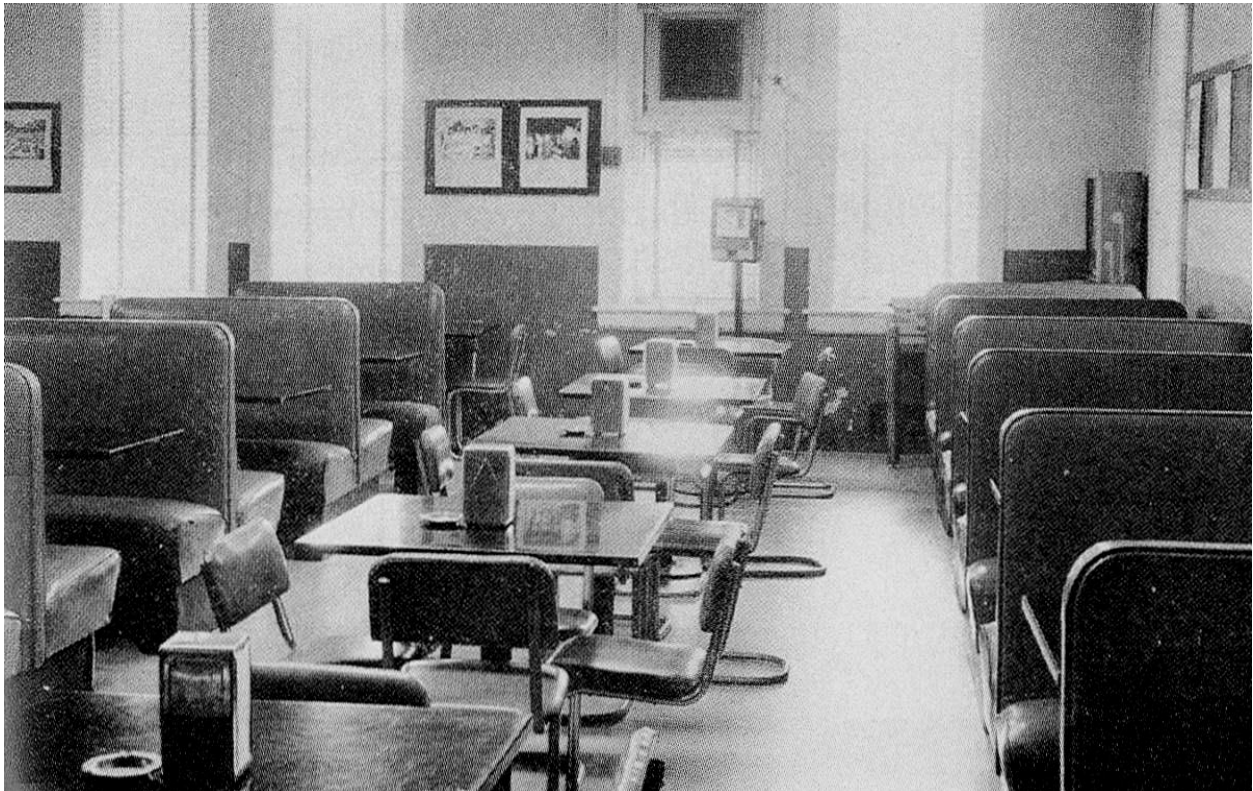
*Figure X - Student Fountain ('The Coop') in 1950, located on the 1st floor, SW corner. Note vinyl booths of the era. There was presumably a kitchen to serve diner. Old Main has been heavily used over the years.*

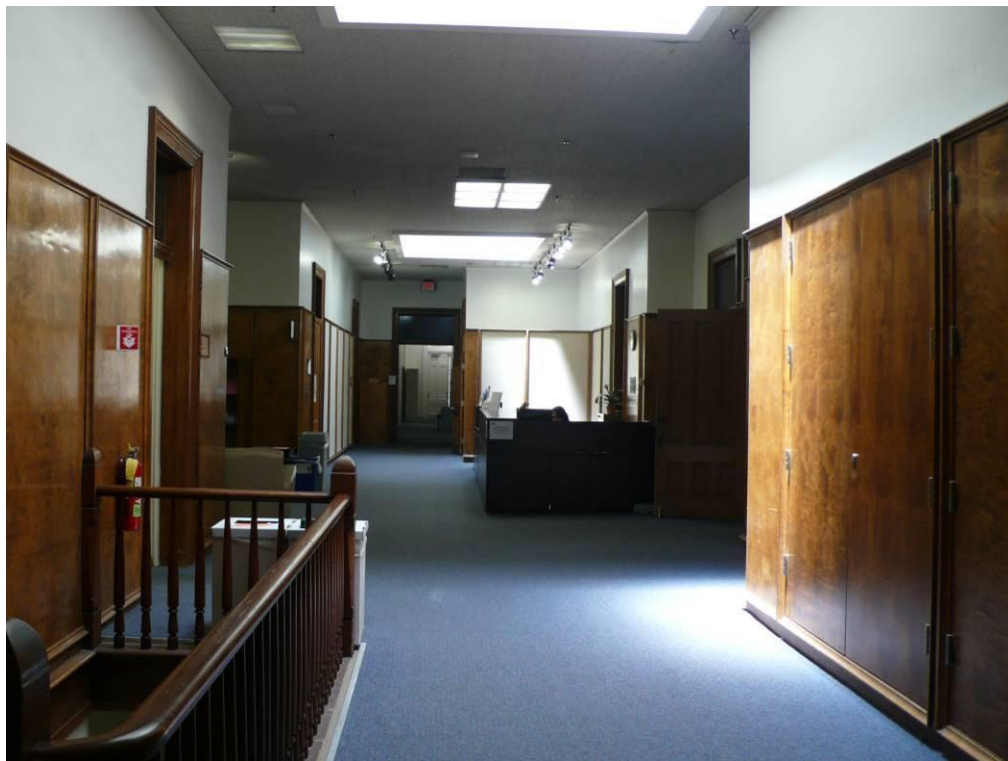
*Figure 52 - 2<sup>nd</sup> floor at central hall looking north, 2011; floor has been carpeted and ceiling dropped with acoustical tile on suspended grid. Original wainscot replaced with 8 ft. tall mahogany paneling.*

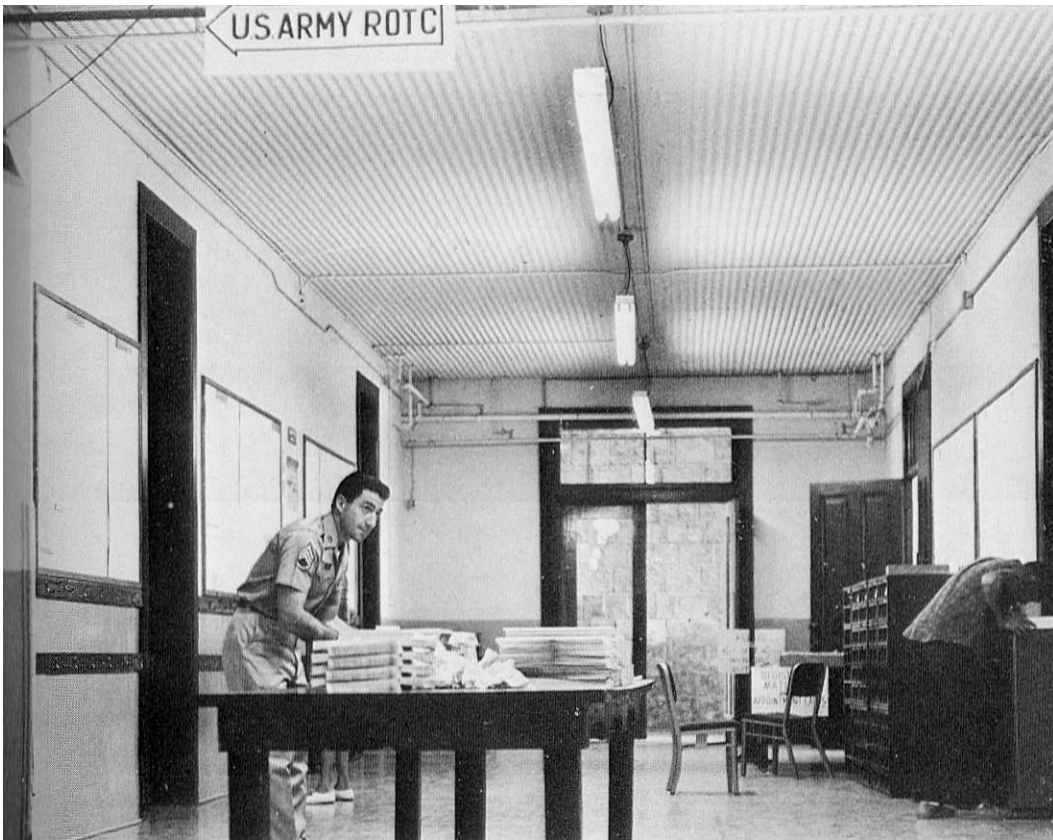
**Figure Z** - 1st floor in 1966 when Old Main was used by ROTC. Note corrugated iron ceiling and 1950s-era fluorescent light fixtures. The US military saved the building from demolition in 1941, when the Department of the Navy refurbished it as a training and recruitment center (Old Main had been condemned by the City of Tucson in 1938 at the height of the Great Depression, when the building was only 46 years old; at that time, it was dilapidated and the UA could not afford repairs). **Figure 53**- Below, the same view in 2011.

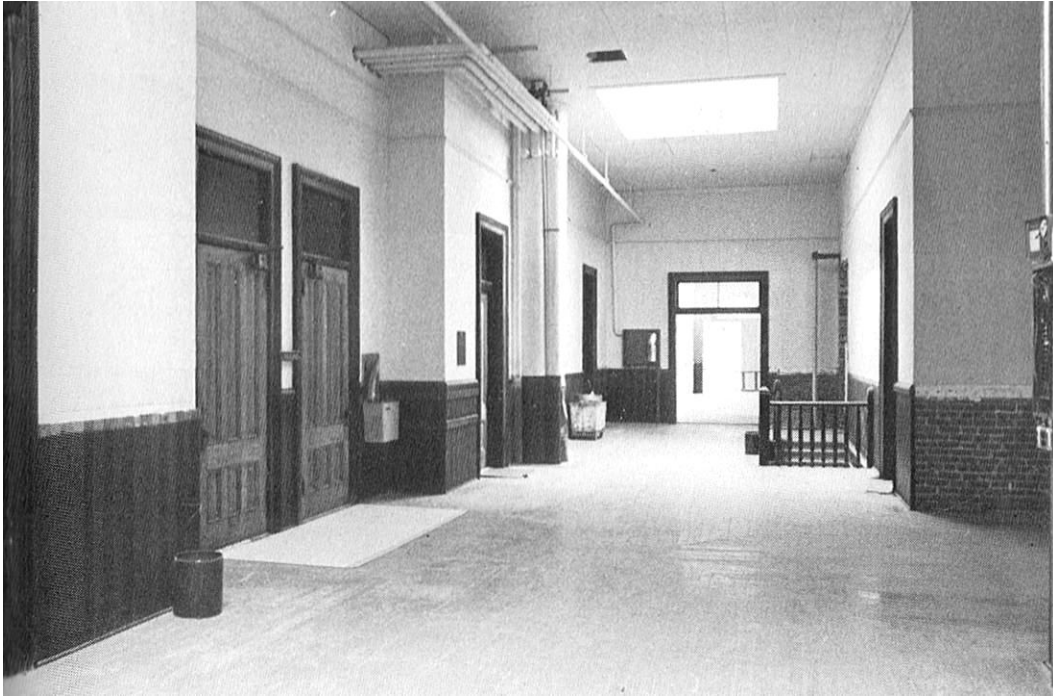
*Figure AA - Interior of second floor under renovation in 1975. Central hall, looking south; stair at right and original wainscoting removed exposing brick beneath. Skylight provides natural day-lighting. Figure 54 - Below, the same view in 2011.*

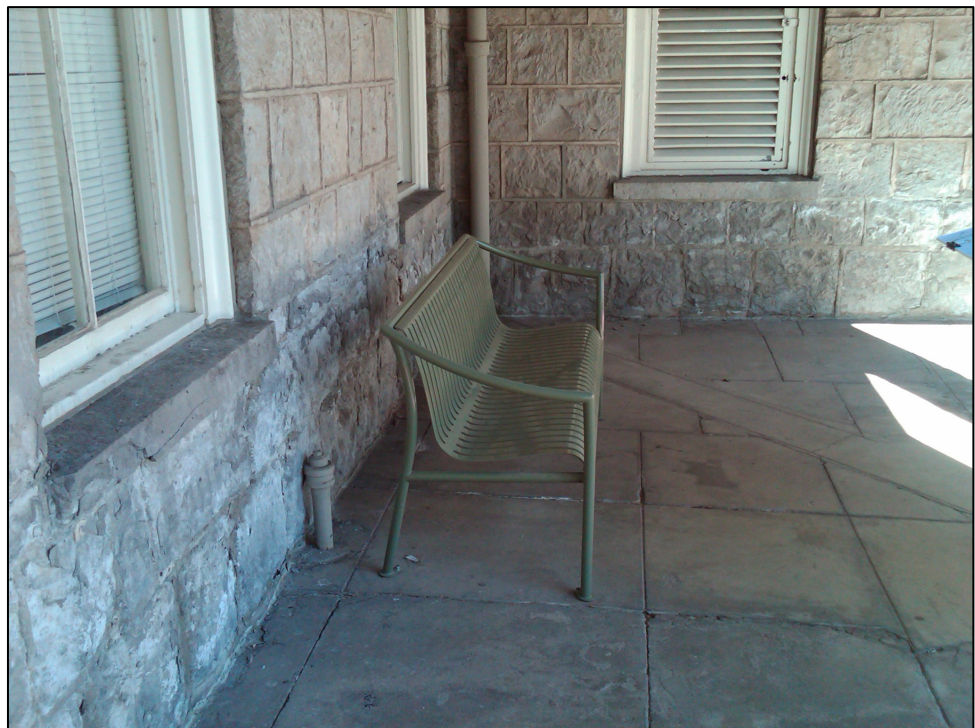
Visual inspection revealed no drain pipes or catch basins to remove water that collects around the exterior of the building. There are eight building downspouts that transport a portion of the roof runoff to the ground just outside of the retaining wall.

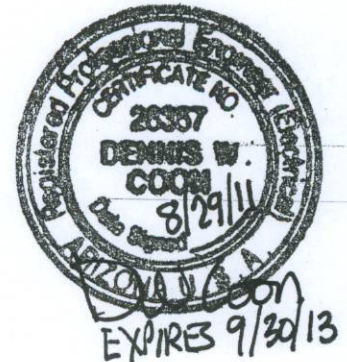
This report is on the electrical systems presently installed at the University of Arizona Old Main Building. The scope of this report covers electrical power, lighting, fire alarm and telecommunications systems installed in the building. Analysis of the Campus distribution system supplying the building is not a part of this report. Included in this report is a list of all found deficiencies along with recommended corrective action and estimates of probable construction costs.

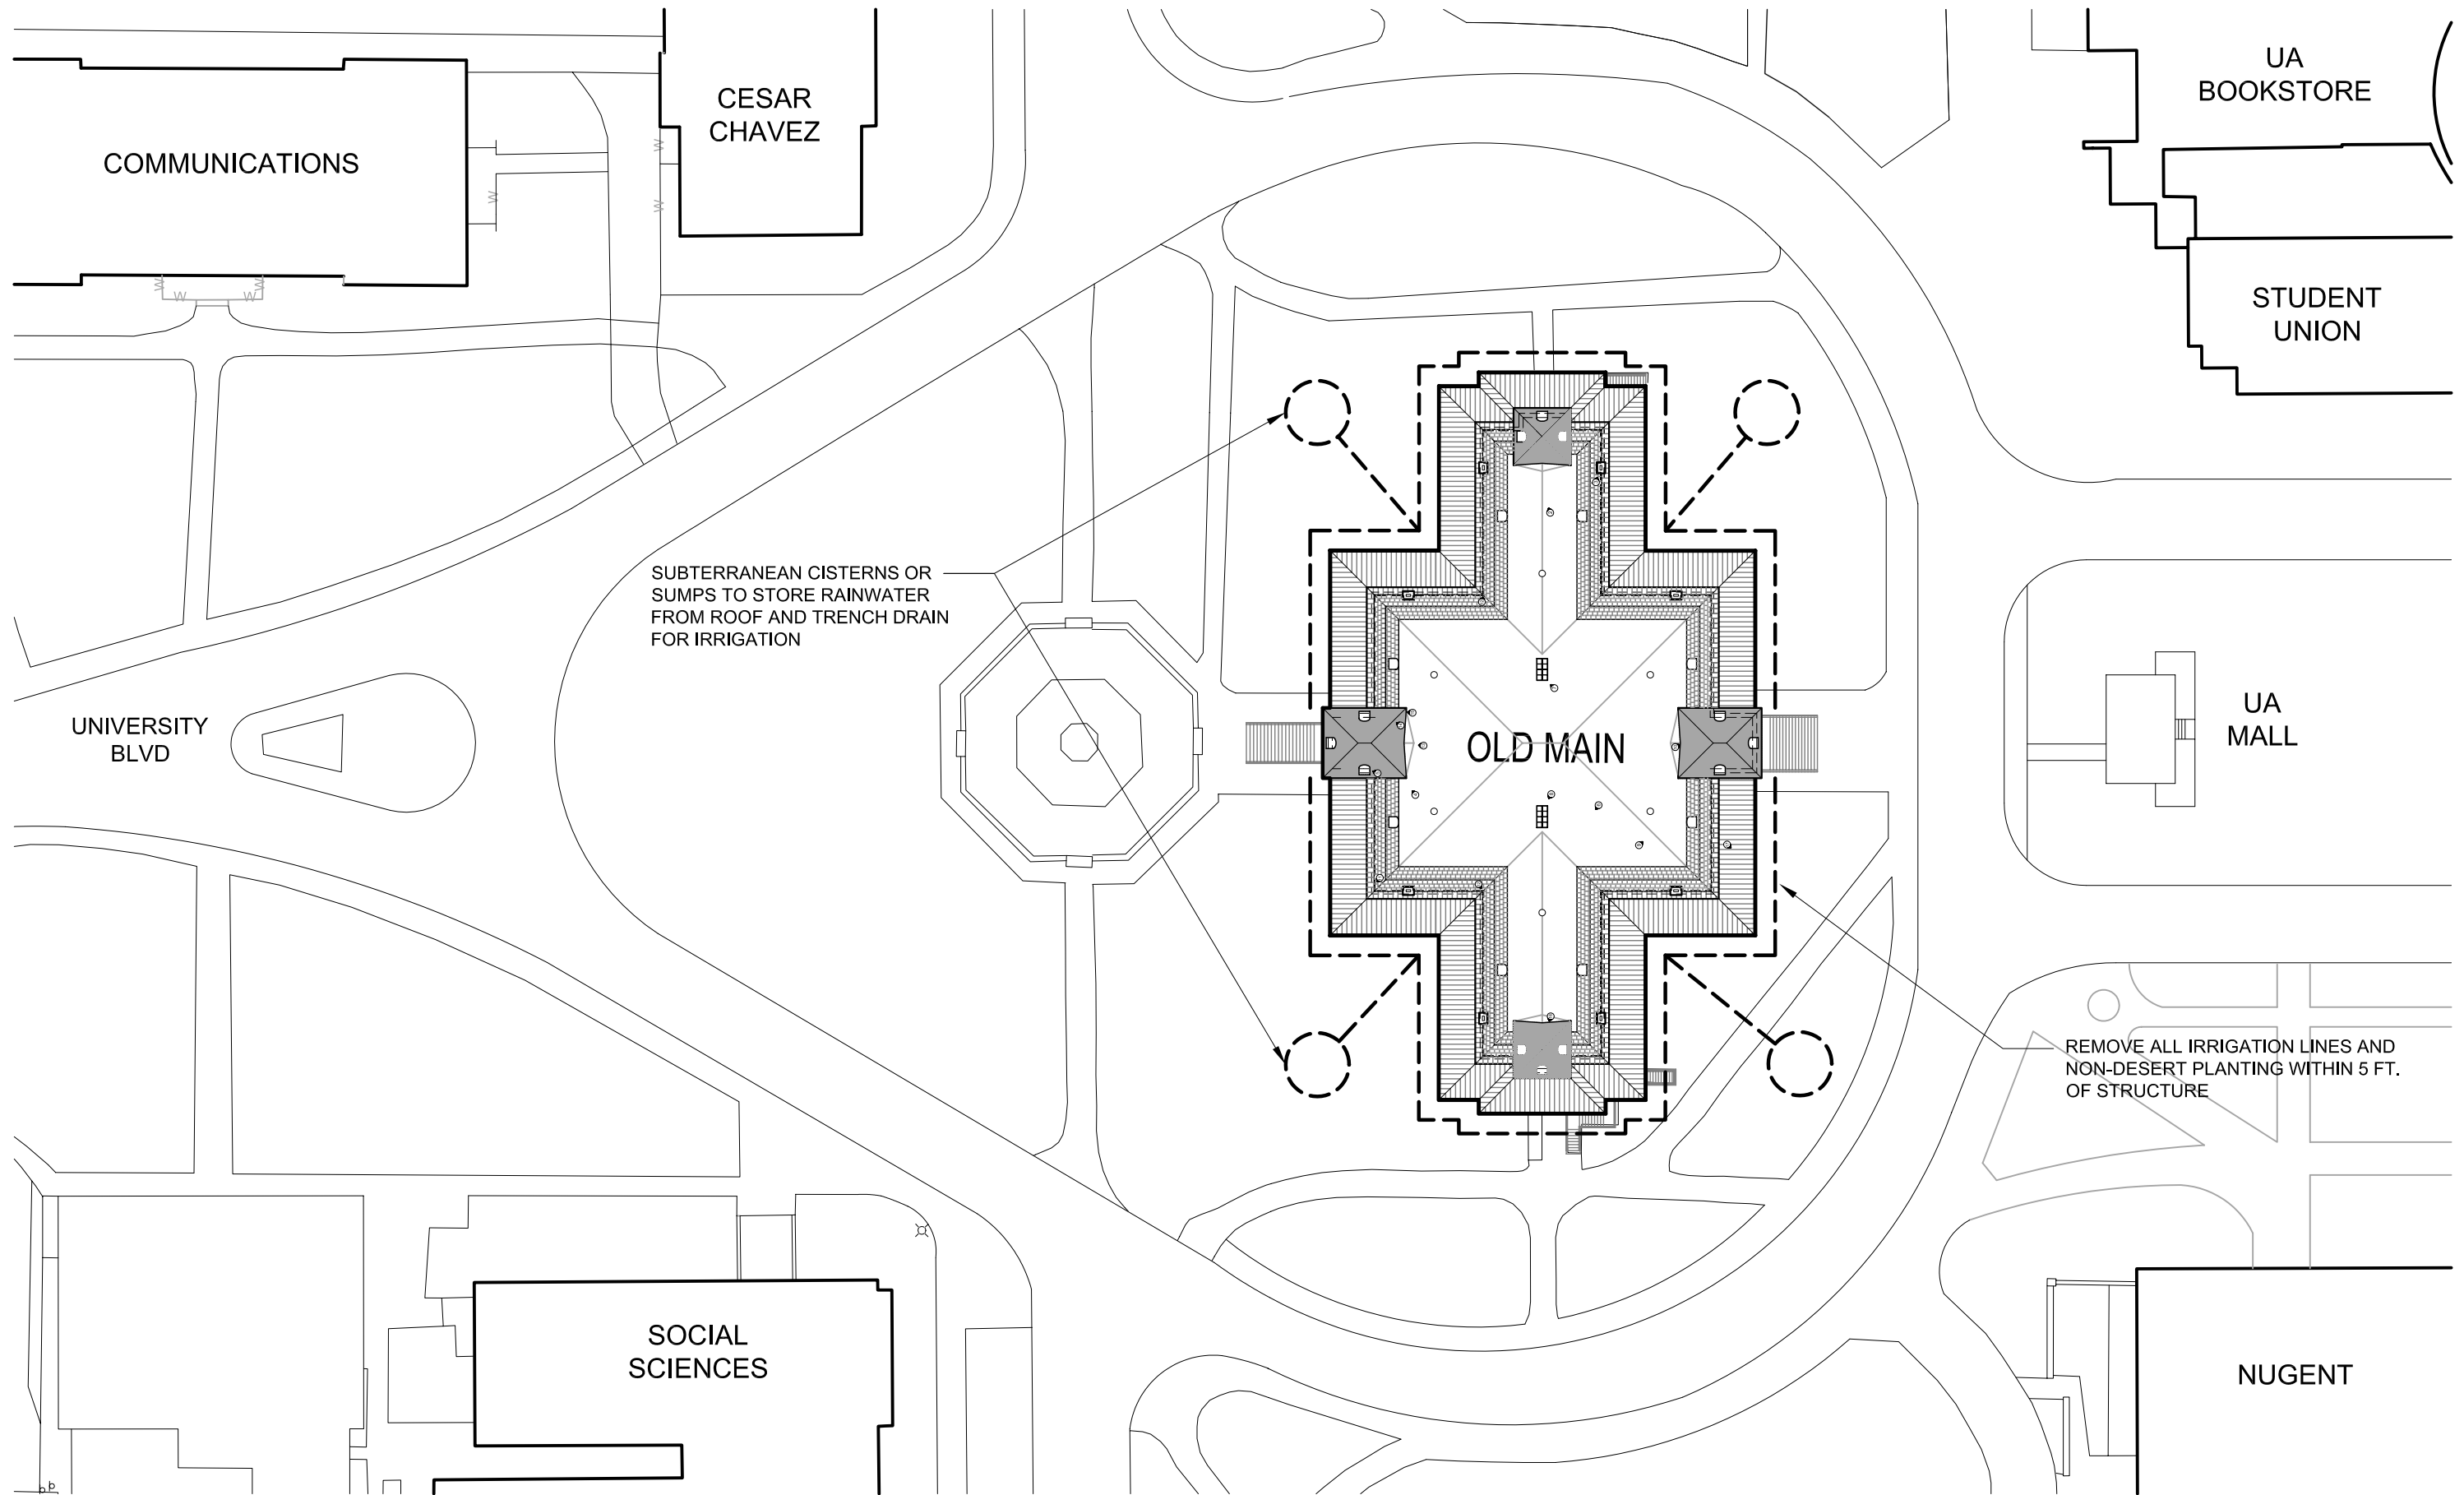
(FOLLOWING THIS PAGE)
