PRESERVATION MASTER PLAN  
FOR  
**OLD MAIN**  
*University of Arizona*  
*Tucson*  
1891~2011

*Designed by James M. Creighton, Architect, 1887*  
*Constructed by M. J. Sullivan, Builder, 1887-1891*

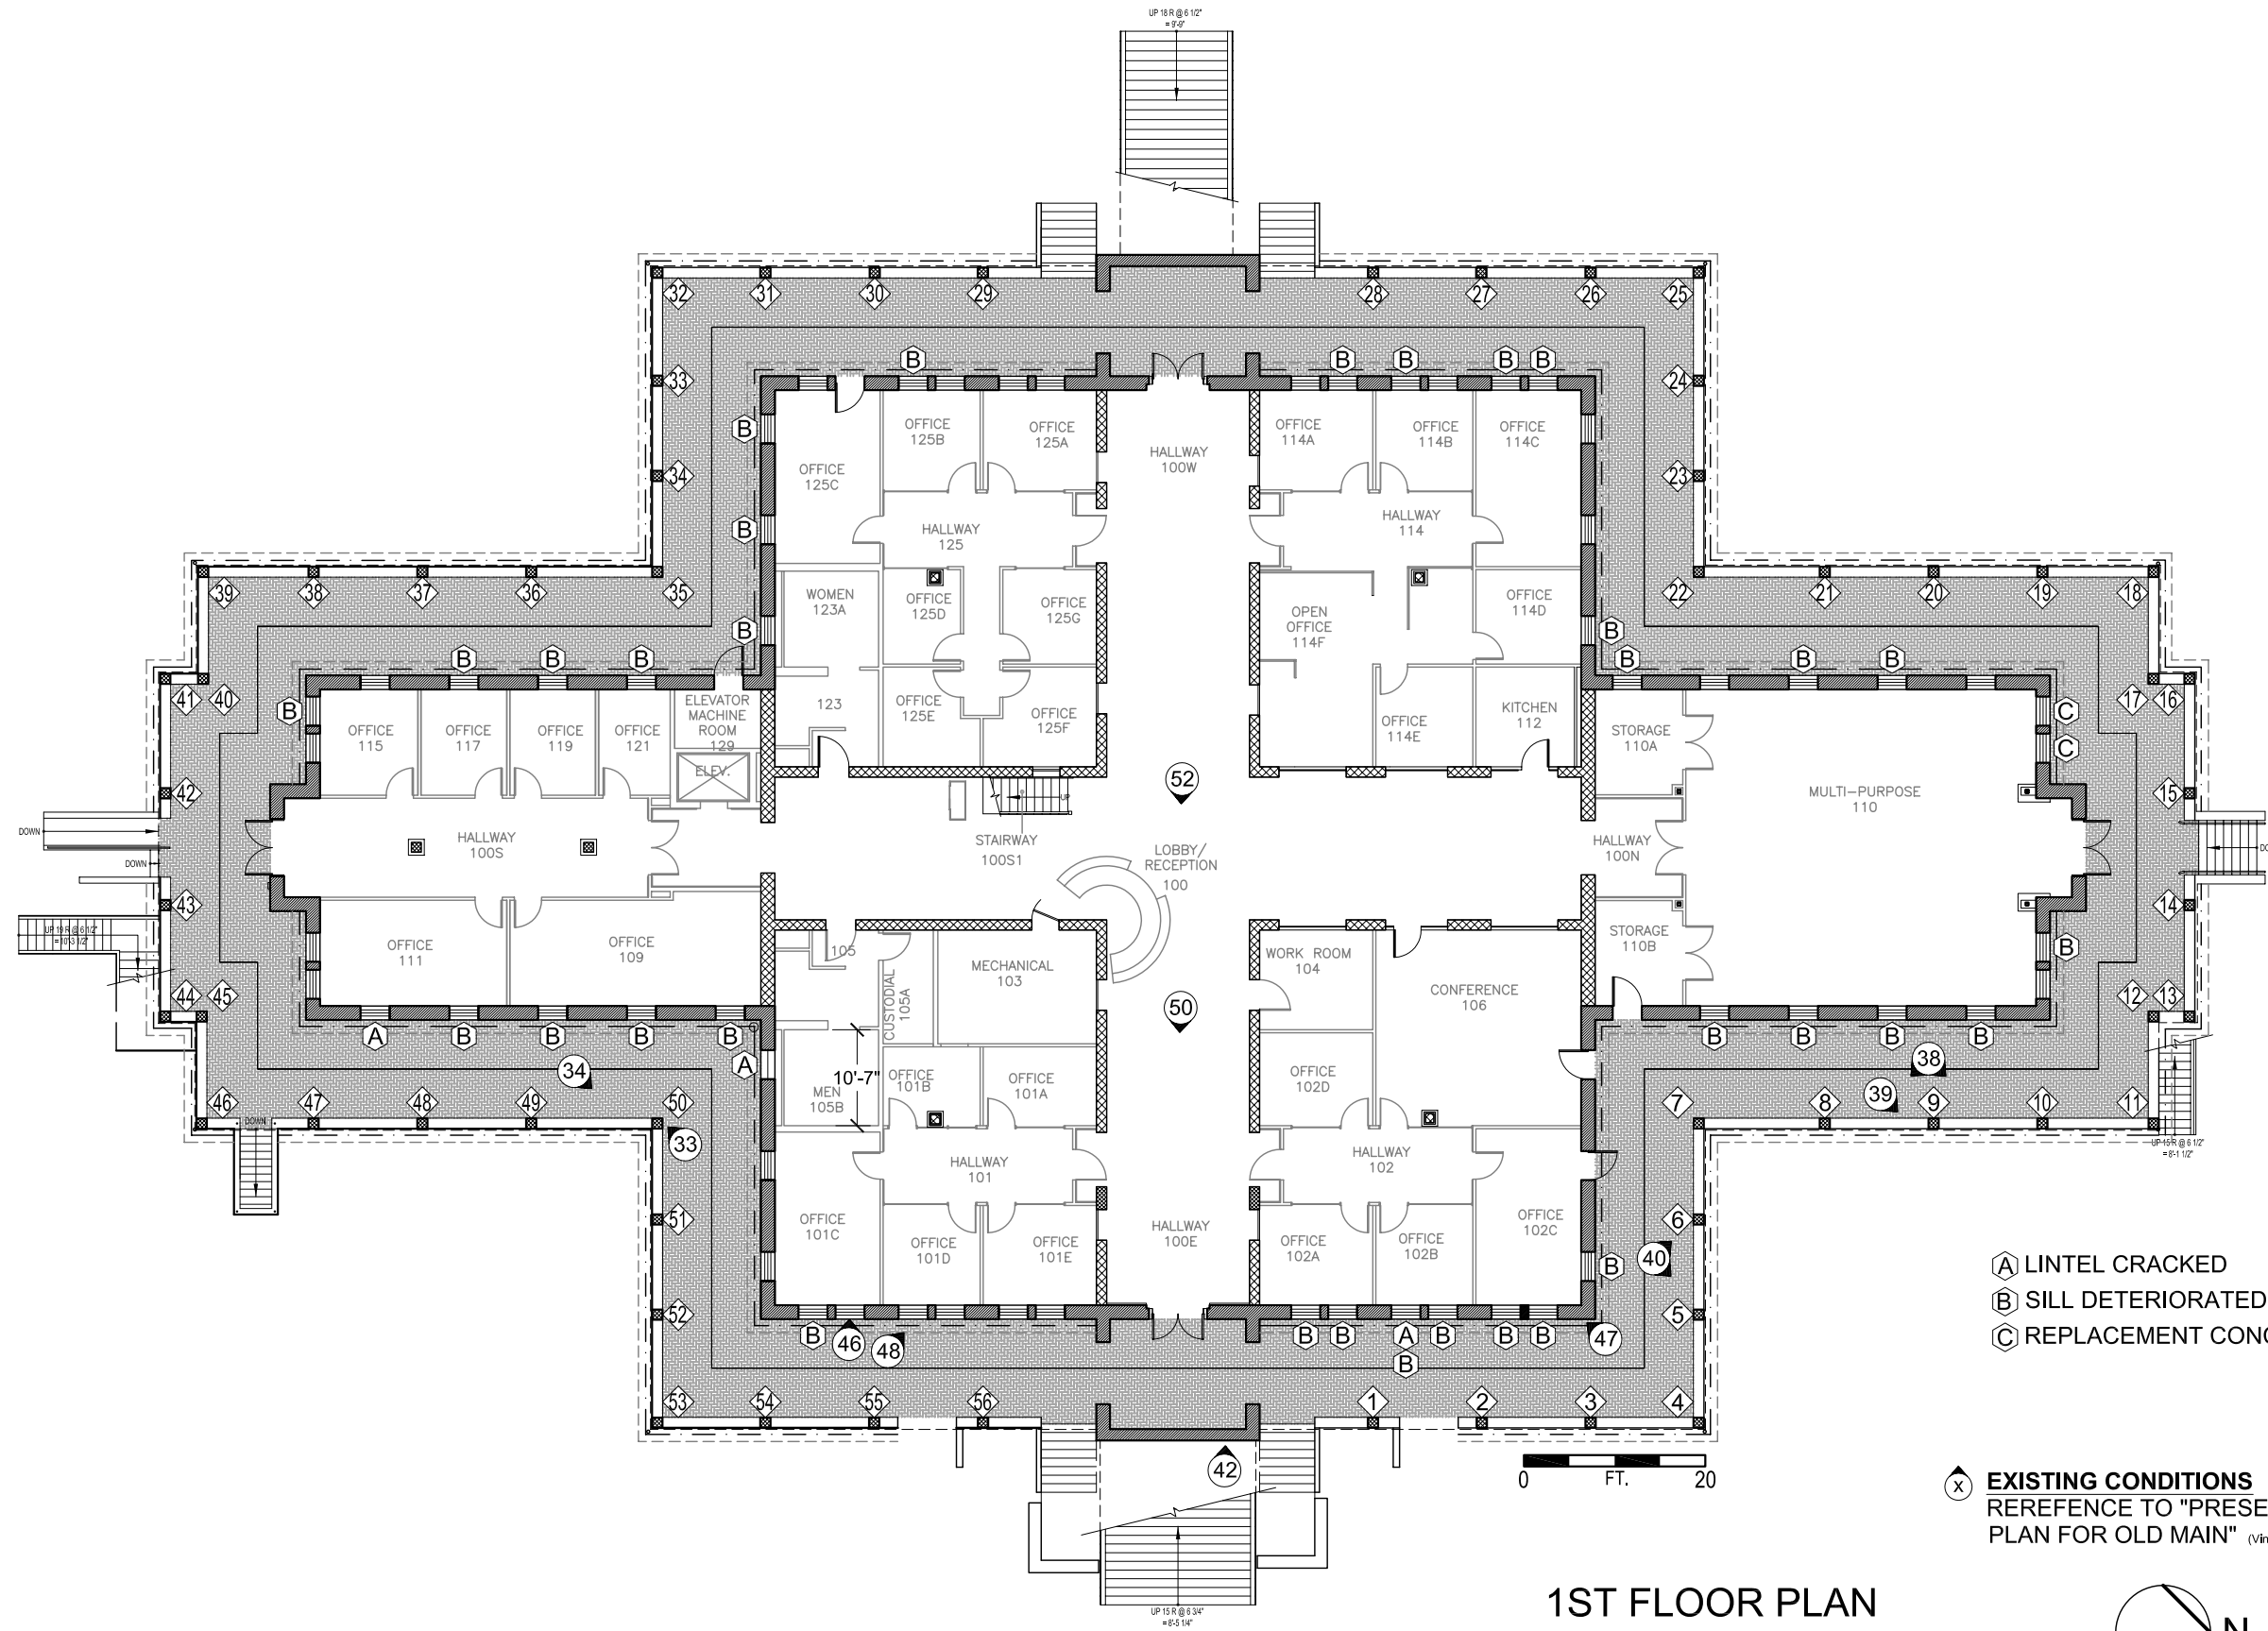
- (A) LINTEL CRACKED
- (B) SILL DETERIORATED / CRACKED
- (C) REPLACEMENT CONCRETE SILLS

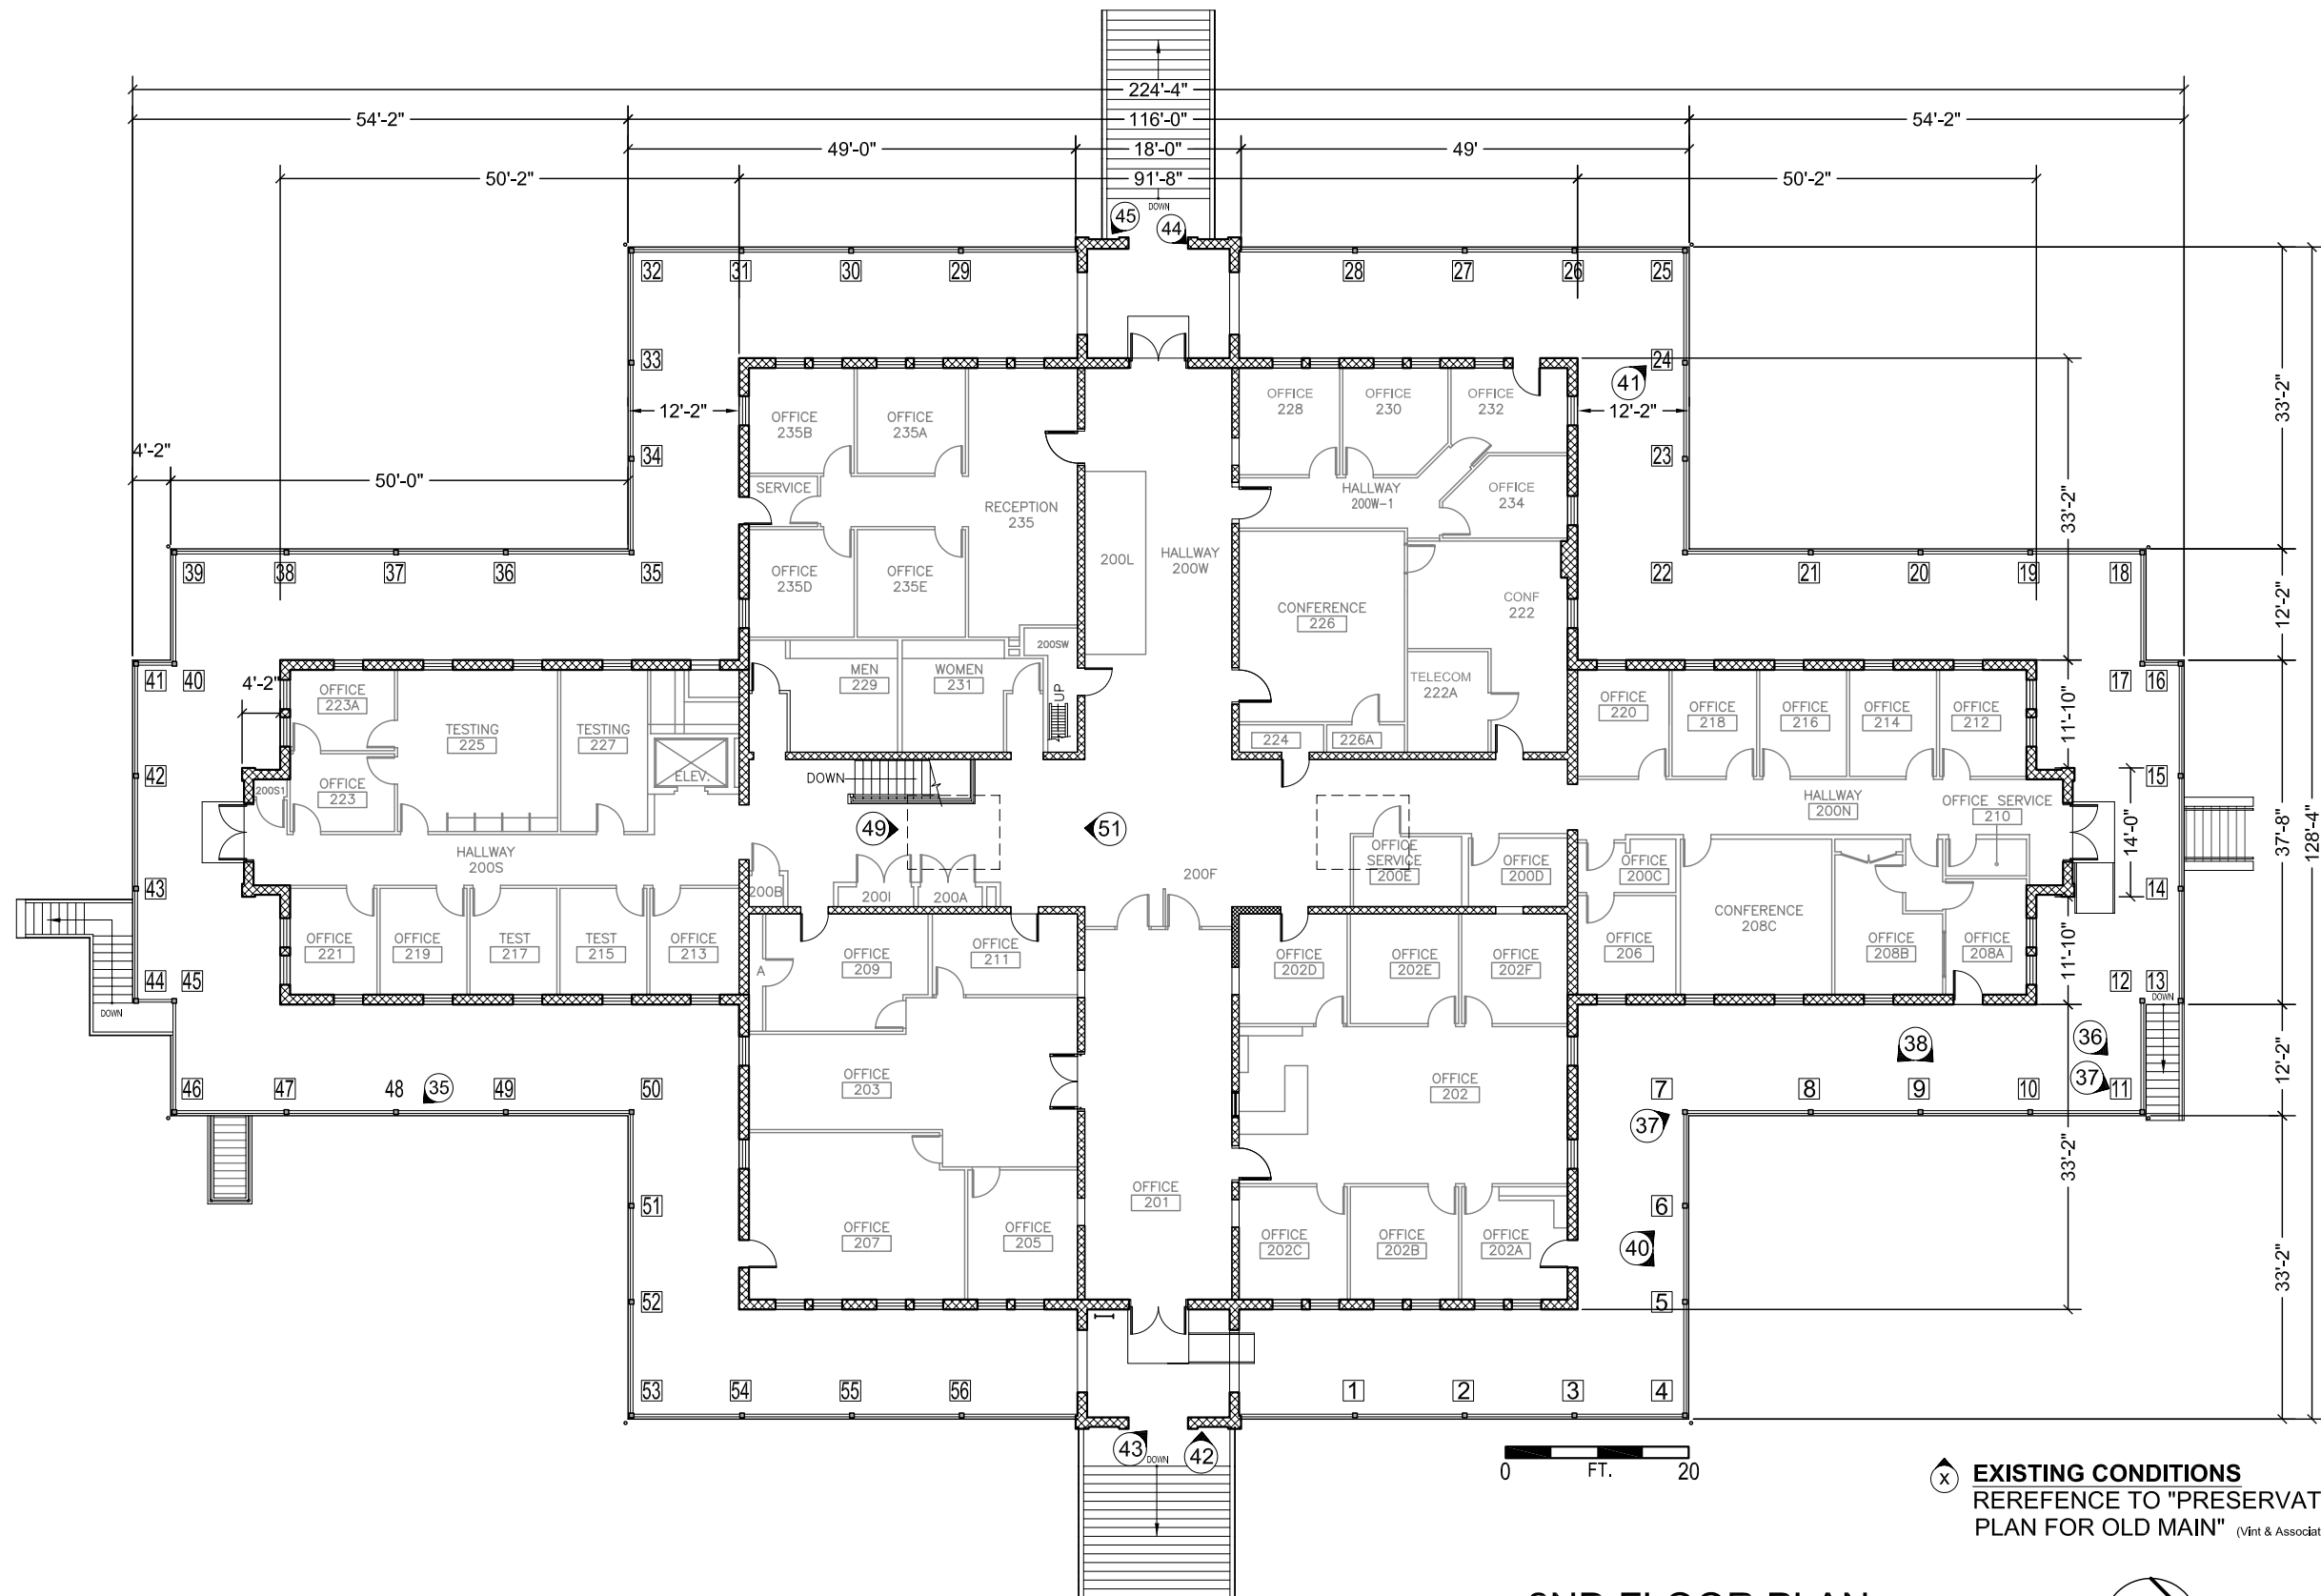
(X) EXISTING CONDITIONS  
 REFERENCE TO "PRESERVATION MASTER  
 PLAN FOR OLD MAIN" (Vint & Associates Inc.)

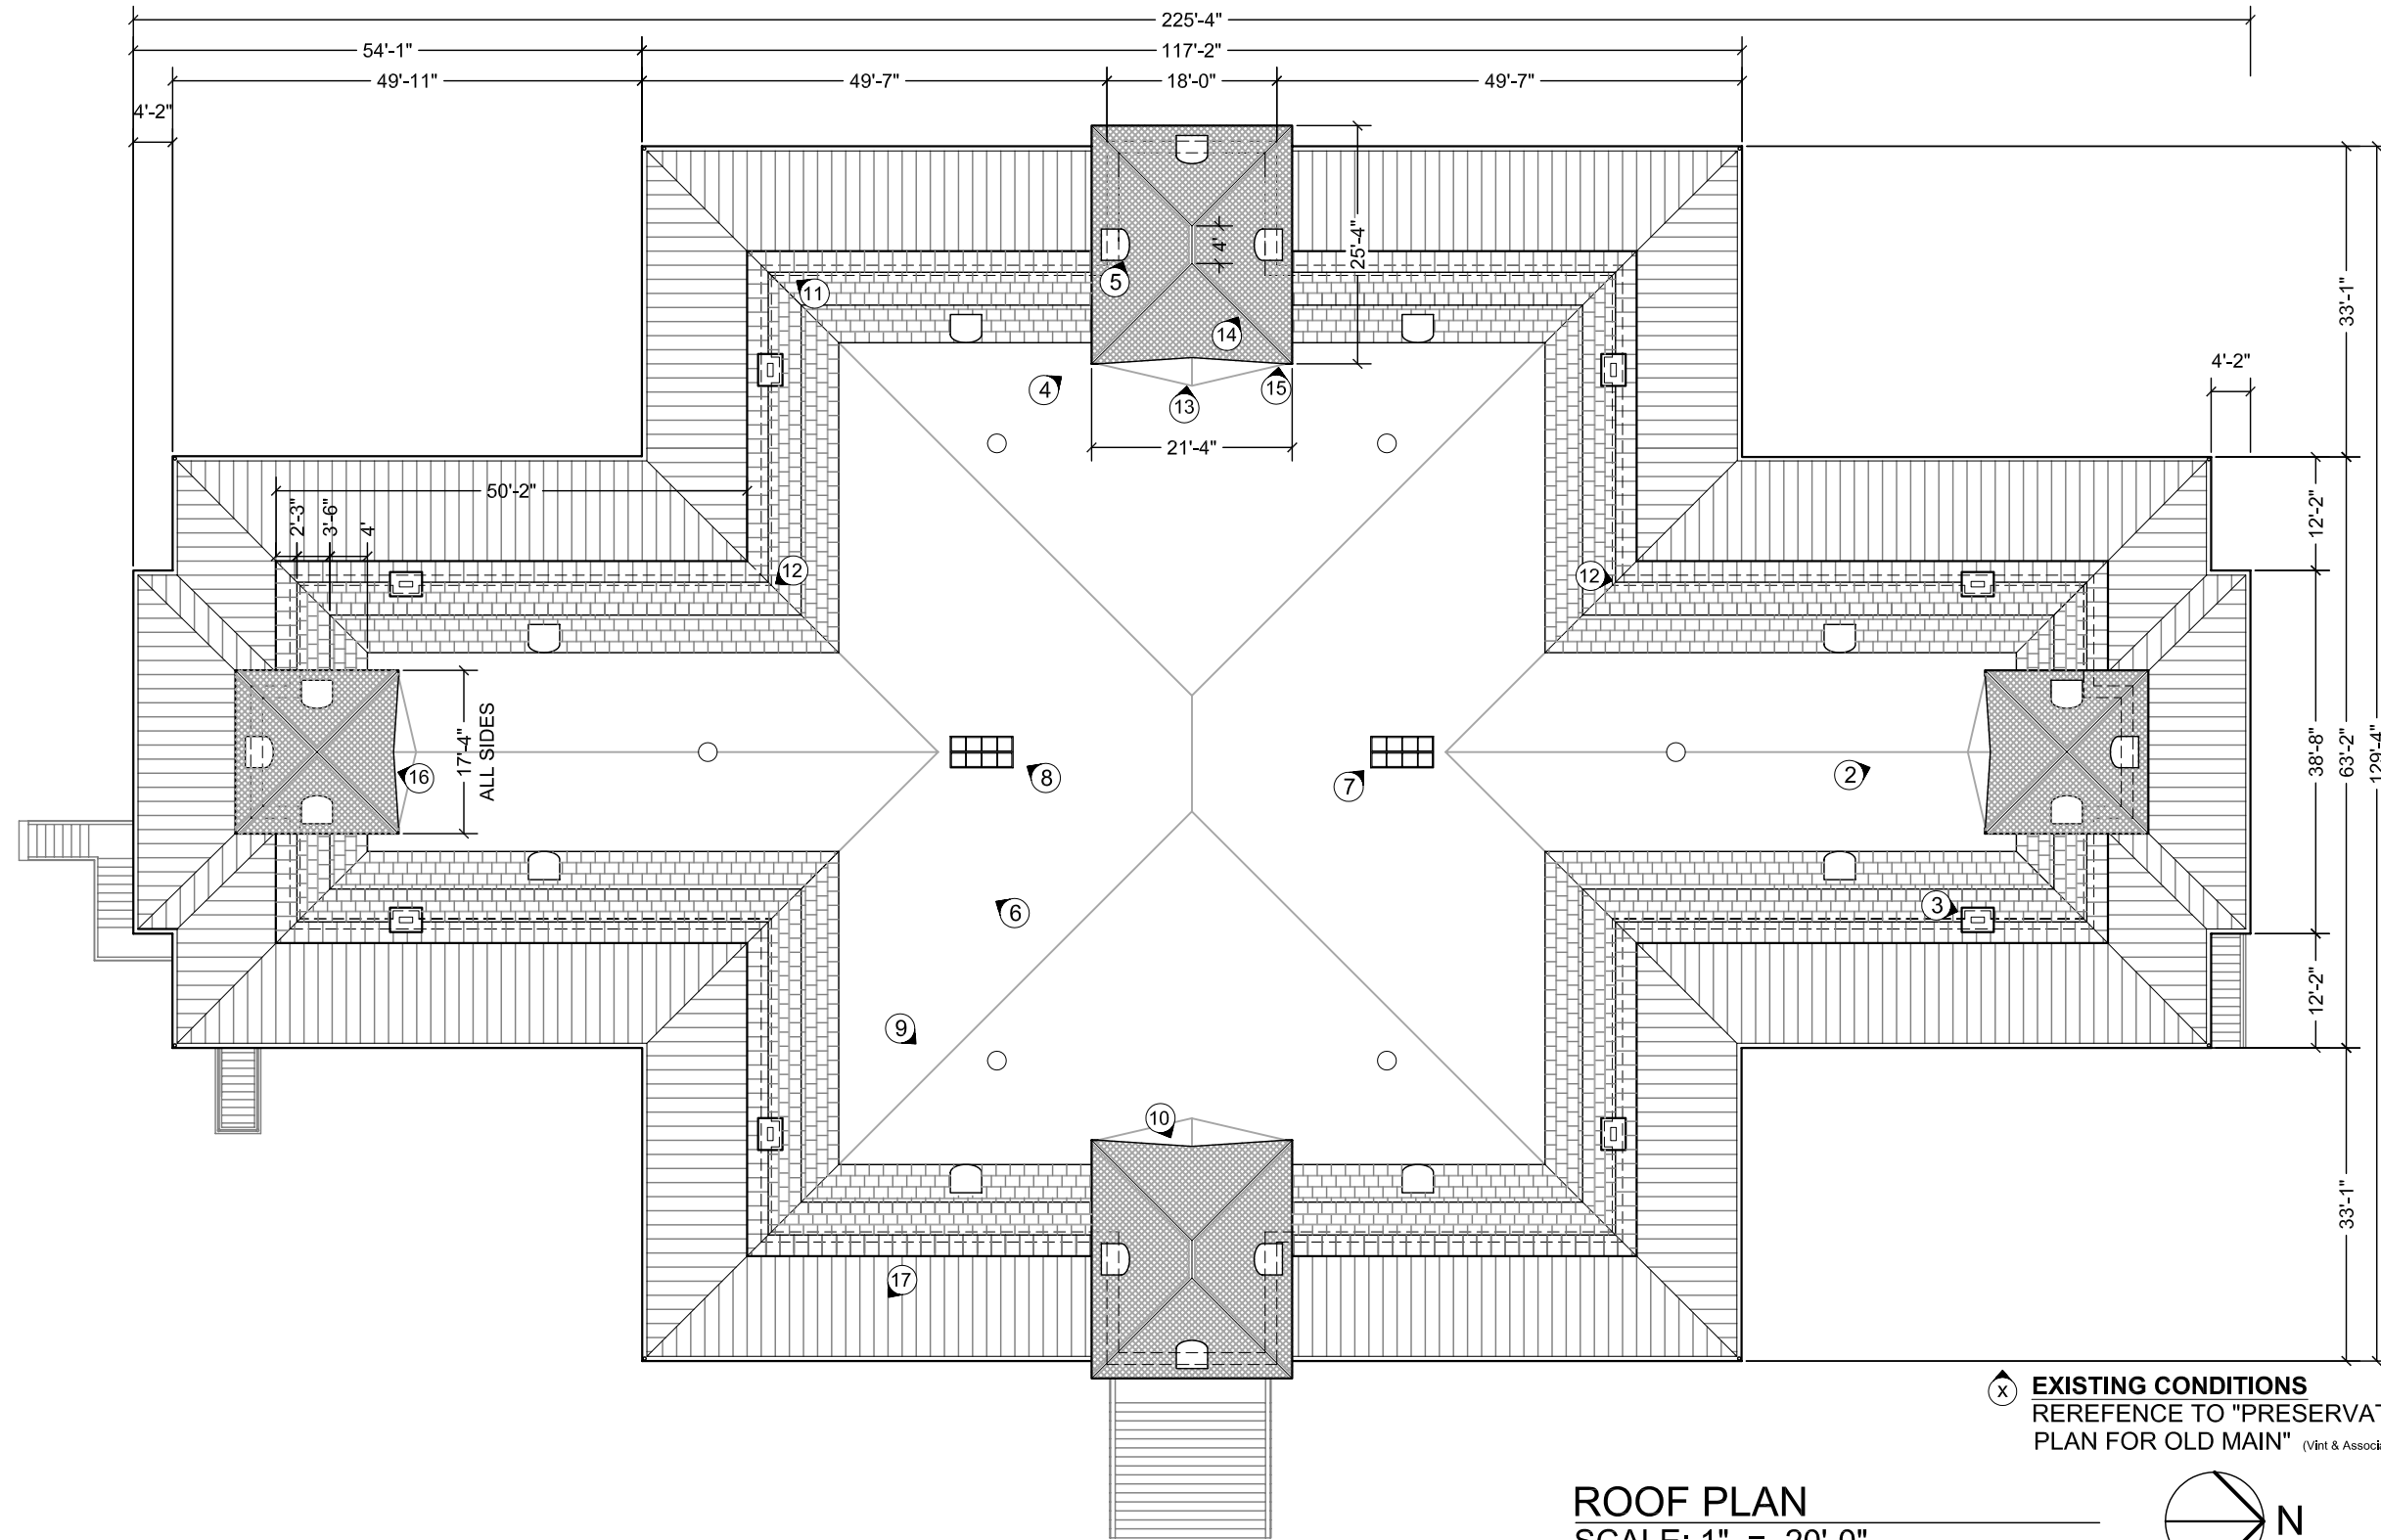
X EXISTING CONDITIONS  
 REREFERENCE TO "PRESERVATION MASTER  
 PLAN FOR OLD MAIN" (Vint & Associates Inc.)

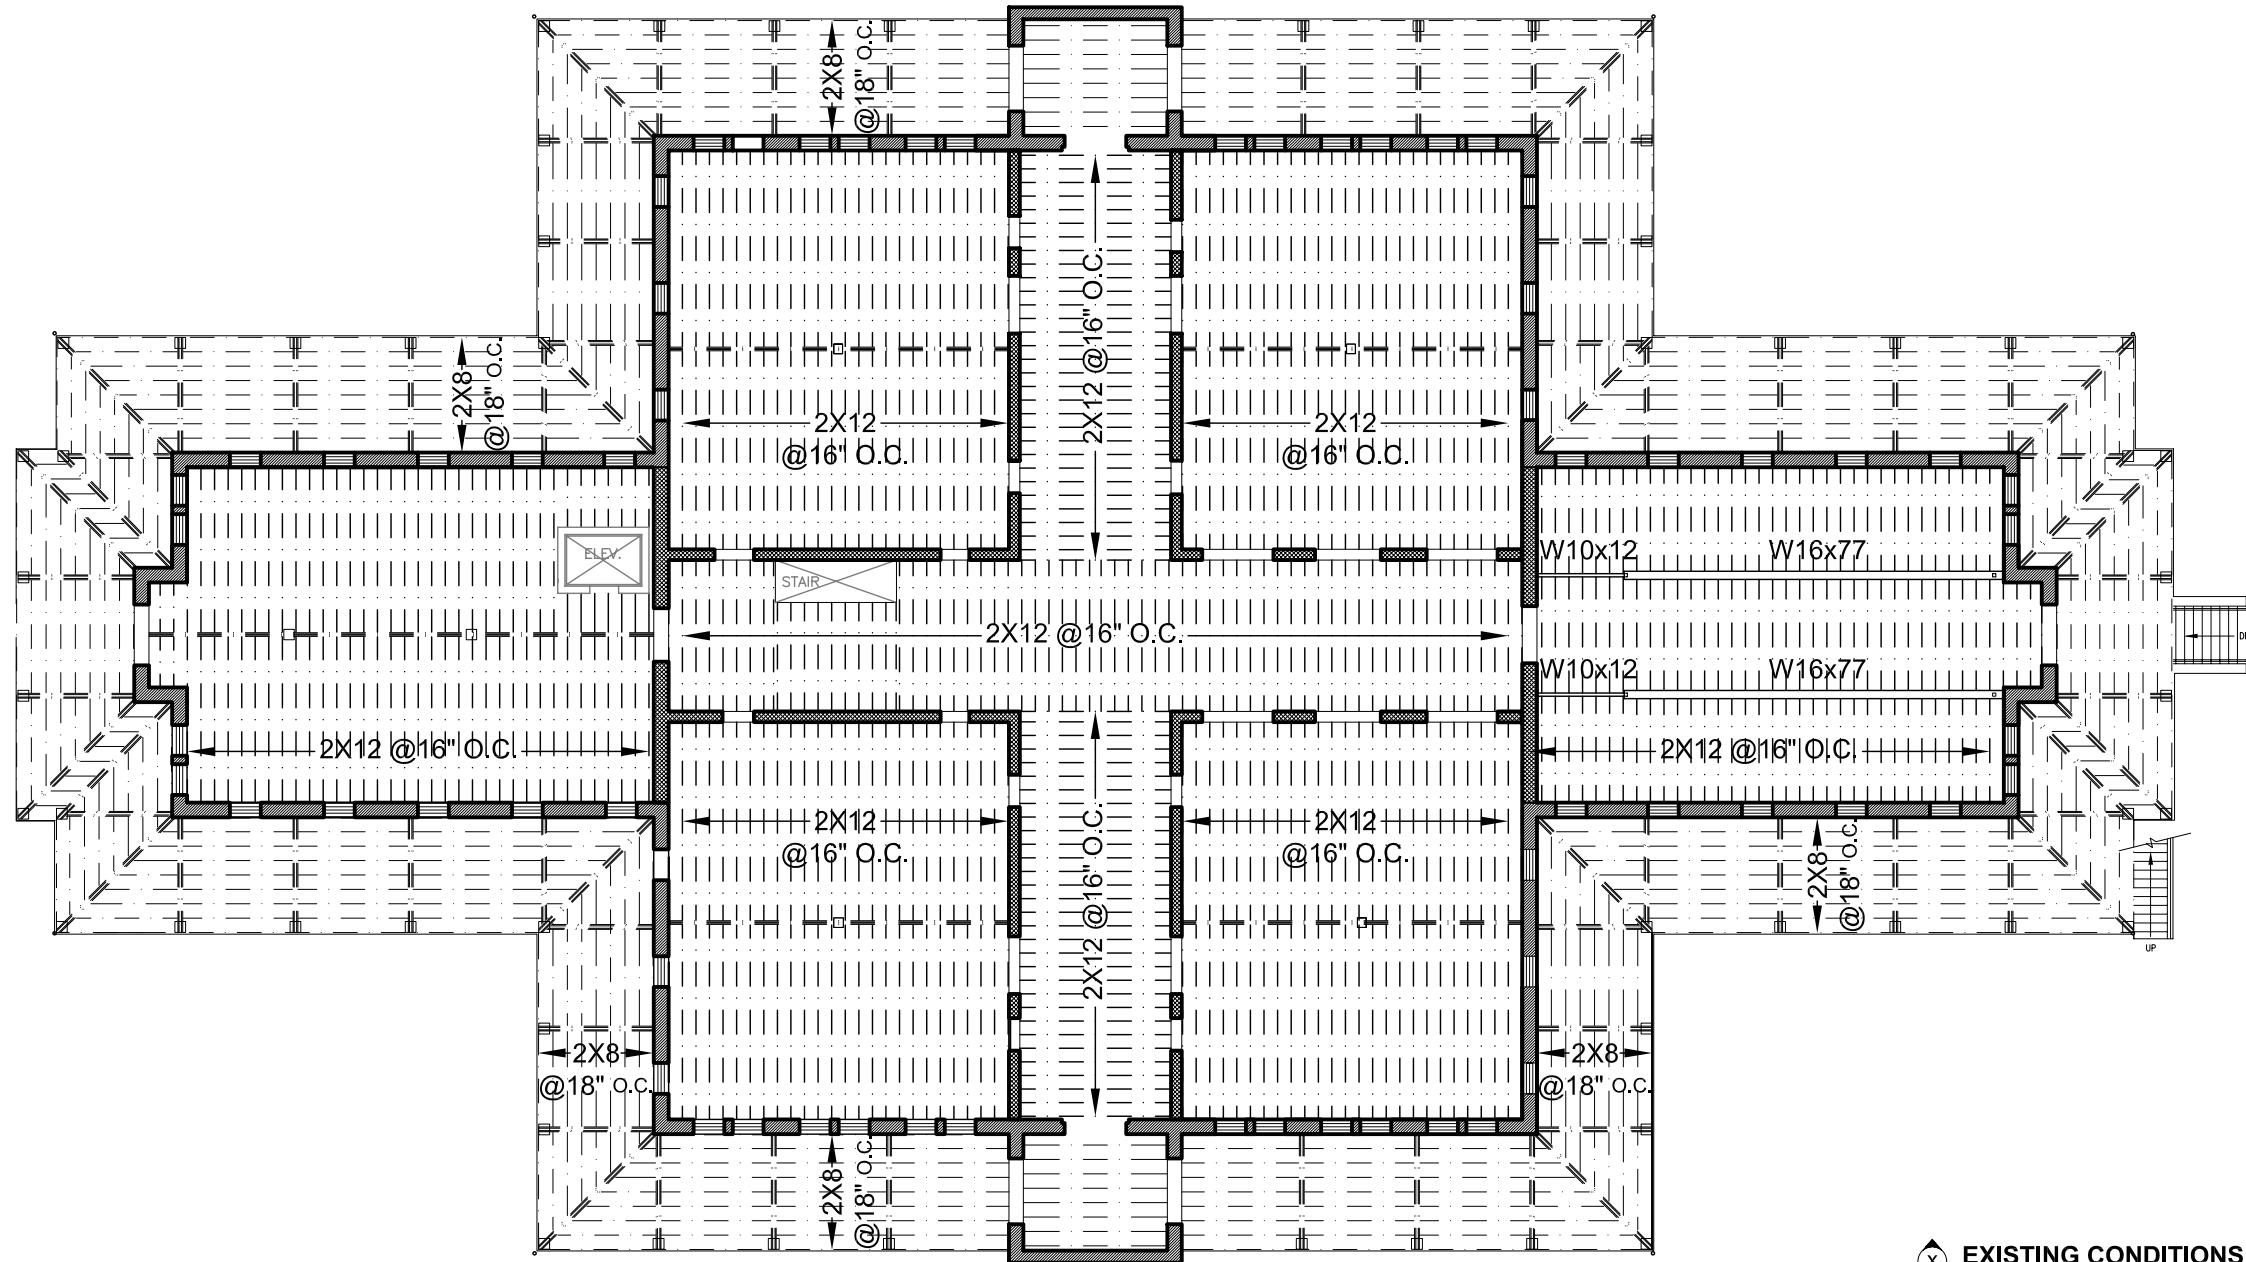
(X) **EXISTING CONDITIONS**  
 REFERENCE TO "PRESERVATION MASTER  
 PLAN FOR OLD MAIN" (Vint & Associates Inc.)

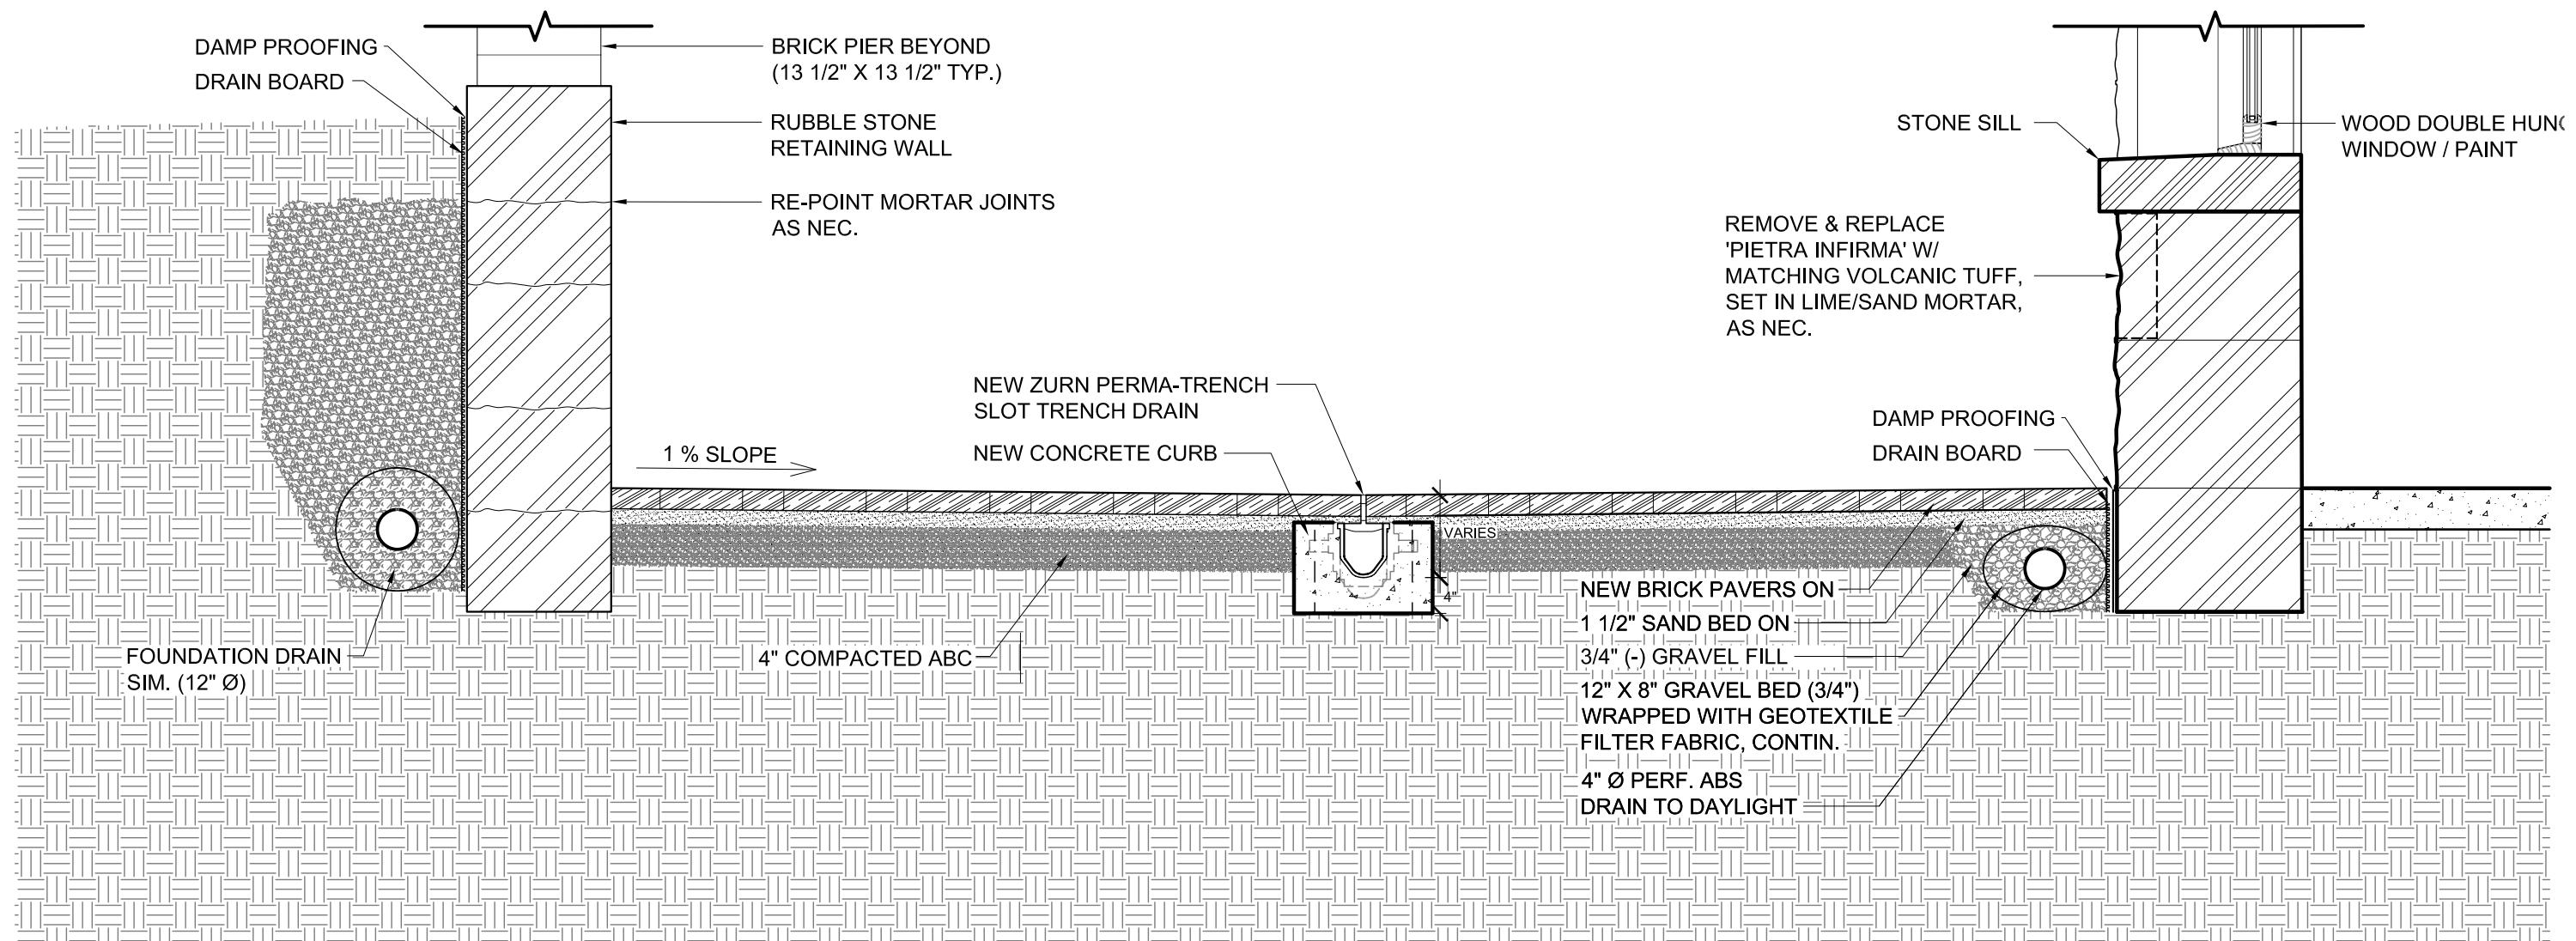
**FOUNDATION DRAINAGE @ 1ST FLOOR**  
 SCALE: 3/4" = 1'-0"

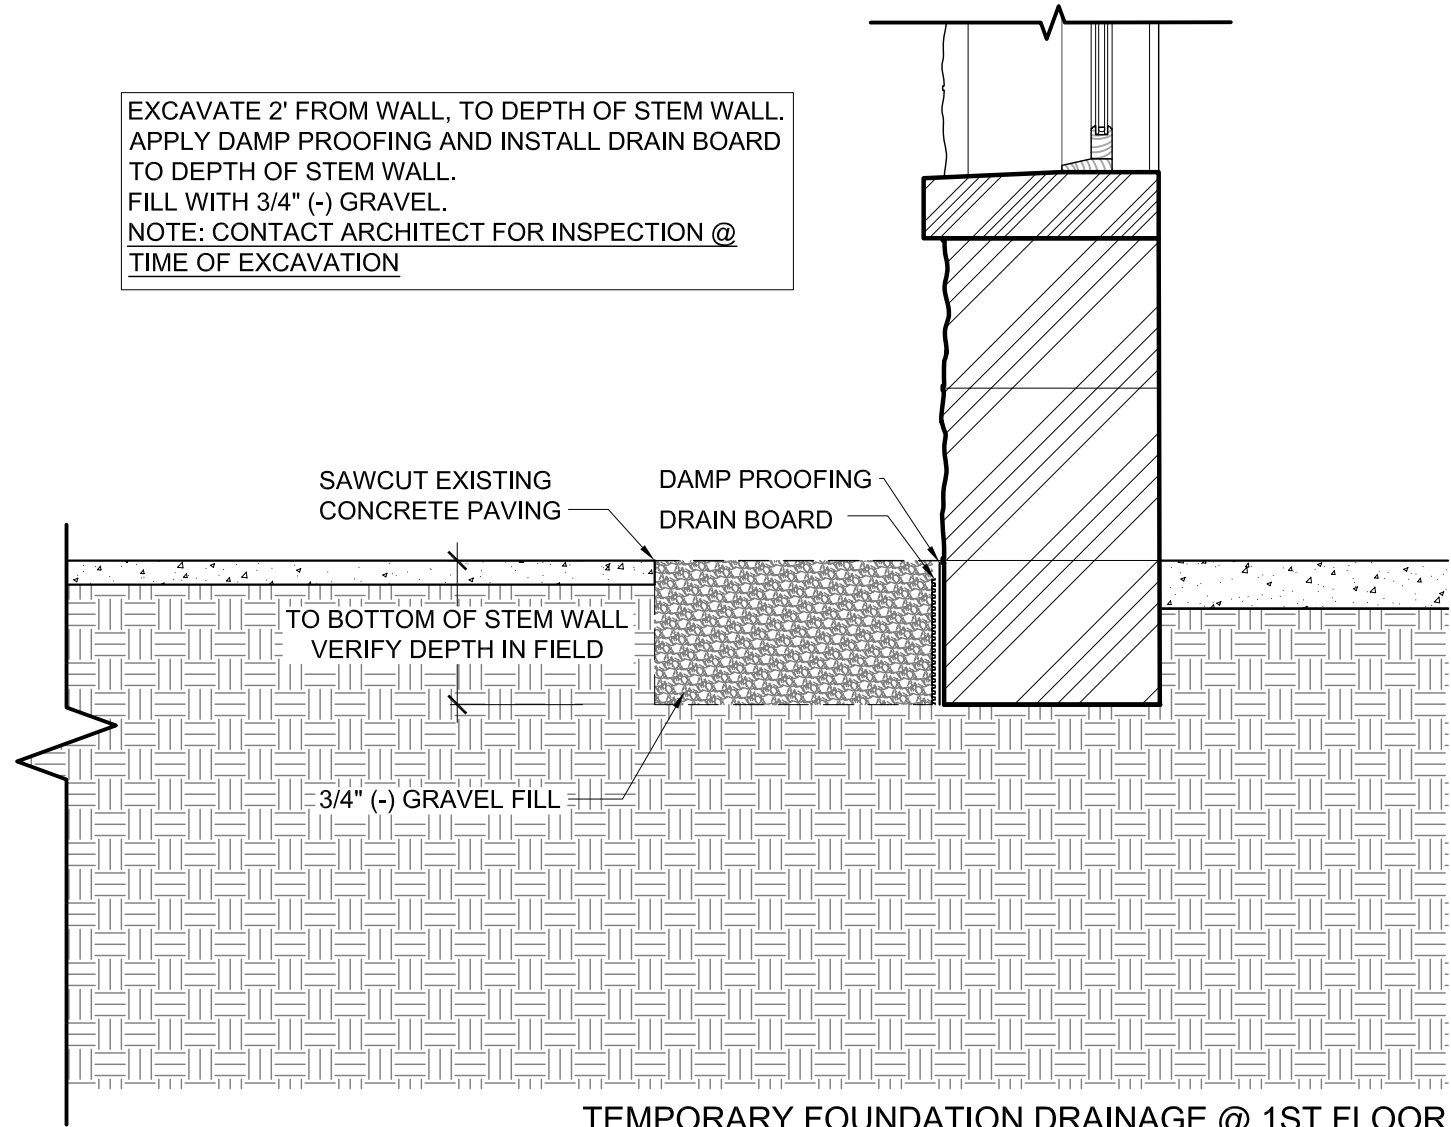
TEMPORARY FOUNDATION DRAINAGE @ 1ST FLOOR  
 SCALE: 3/4" = 1'-0"

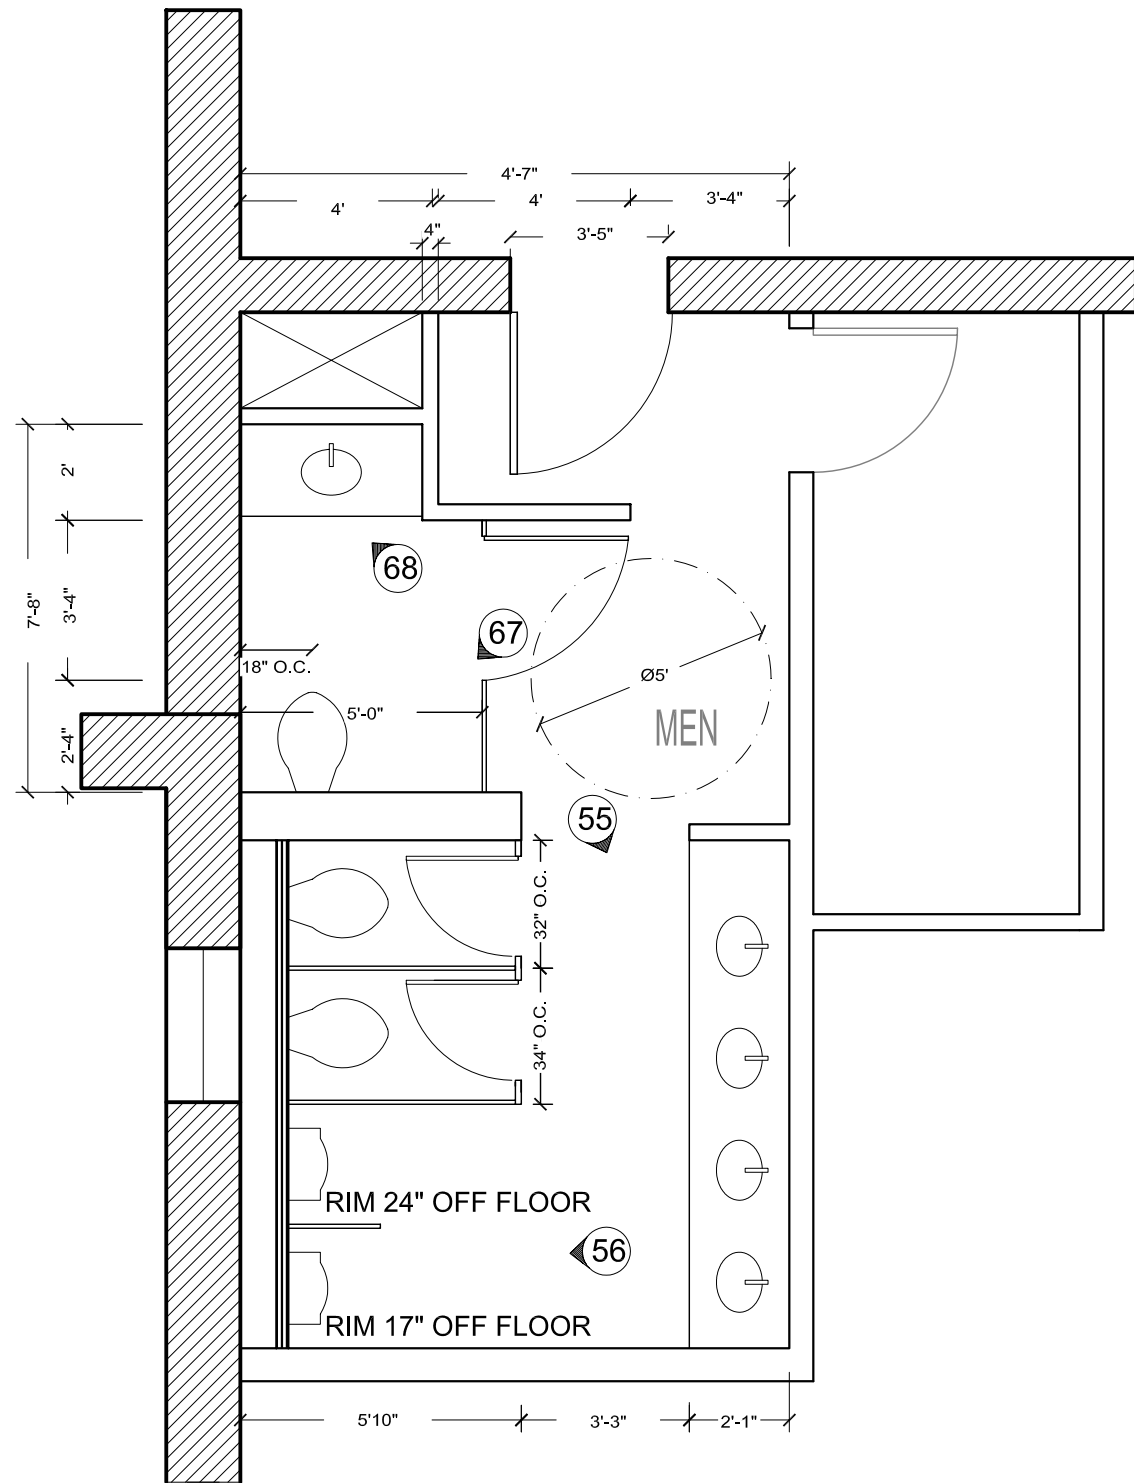
**MEN'S @ FIRST FLOOR RESTROOM**  
 SCALE: 1/4" = 1'-0"

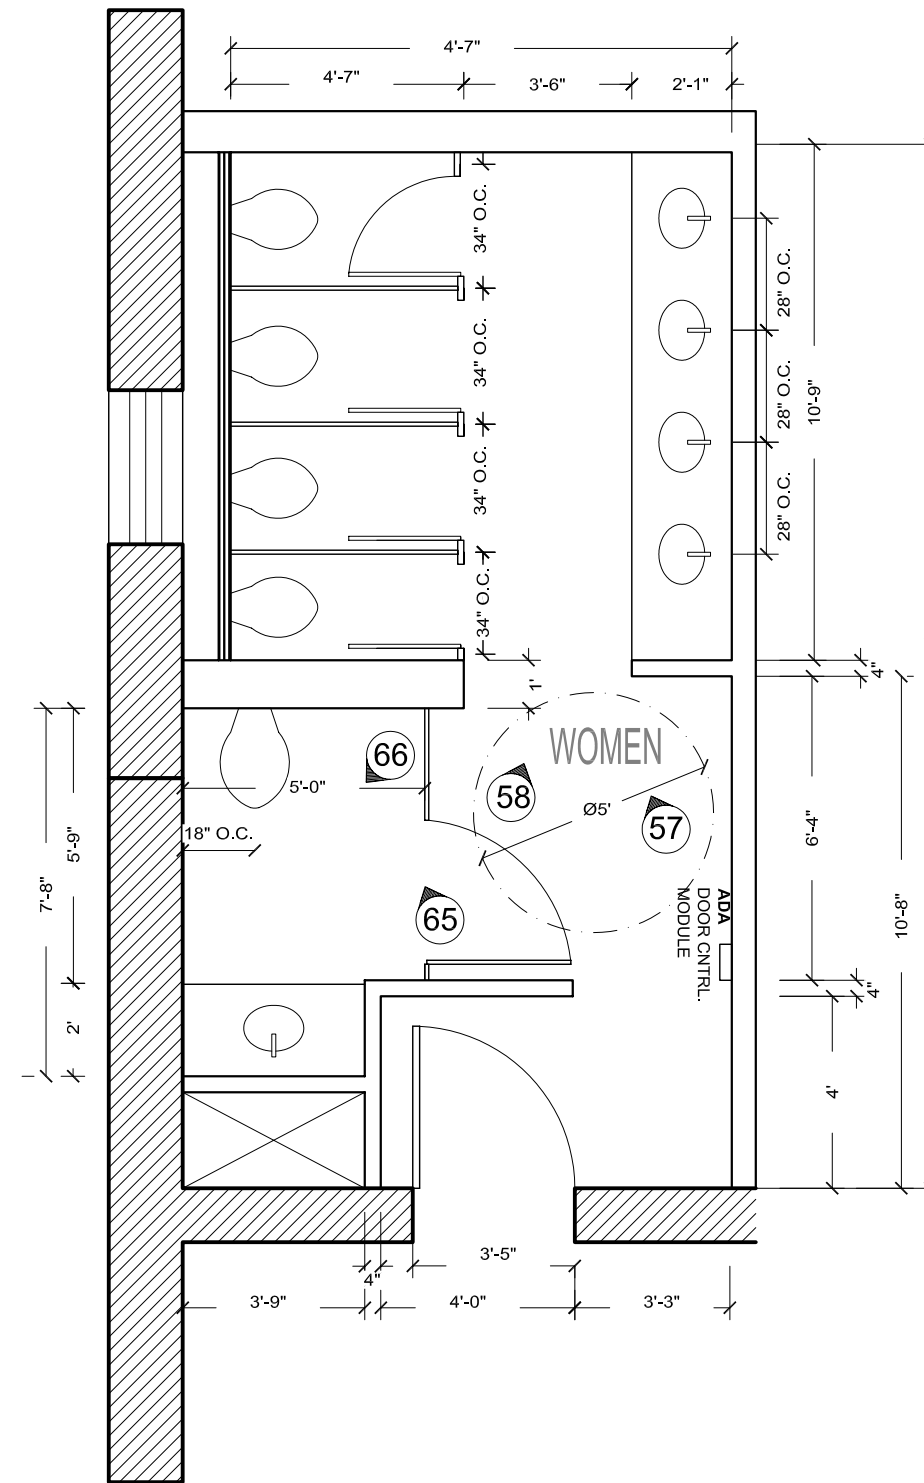
**WOMEN'S @ FIRST FLOOR RESTROOM**  
 SCALE: 1/4" = 1'-0"

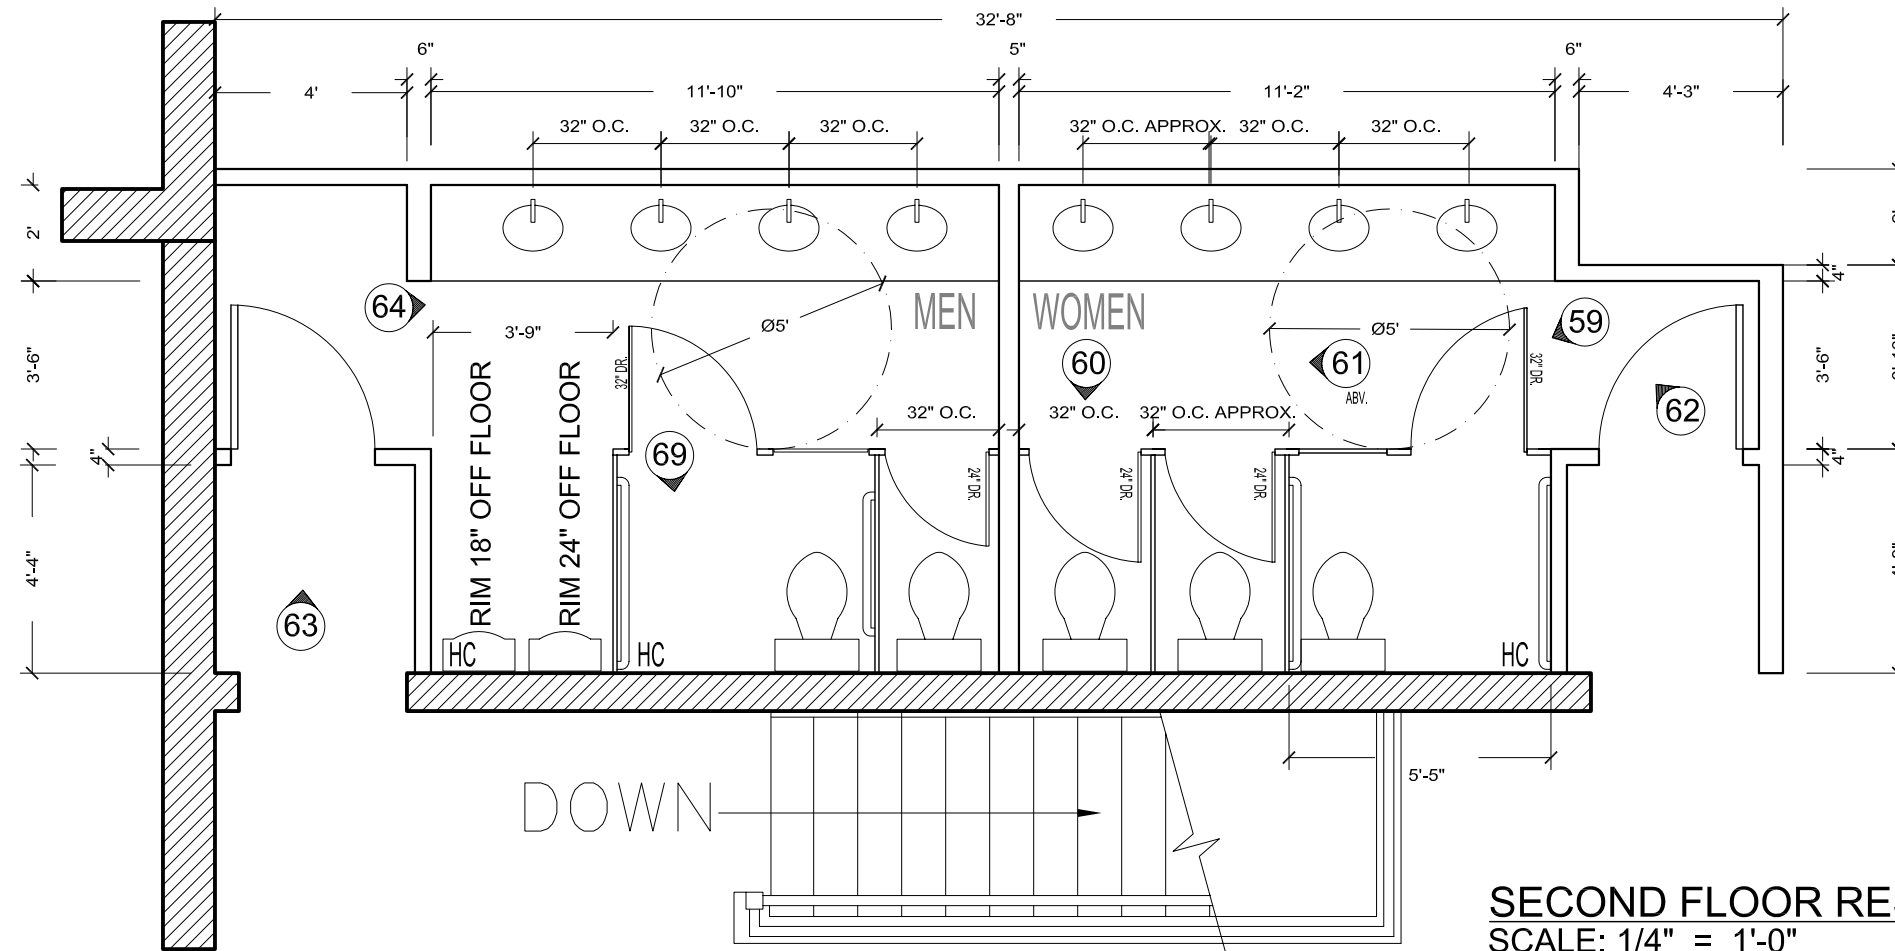
**SECOND FLOOR RESTROOMS**  
 SCALE: 1/4" = 1'-0"
